Commissioners' Meeting Agenda Item Request  
Date of Meeting: 03-21-17

Stormo Investments v. Dennis Banks Construction  
Plaintiff Cost of Repair

**Plaintiff Cost of Repair  
Estimate Summary Report**

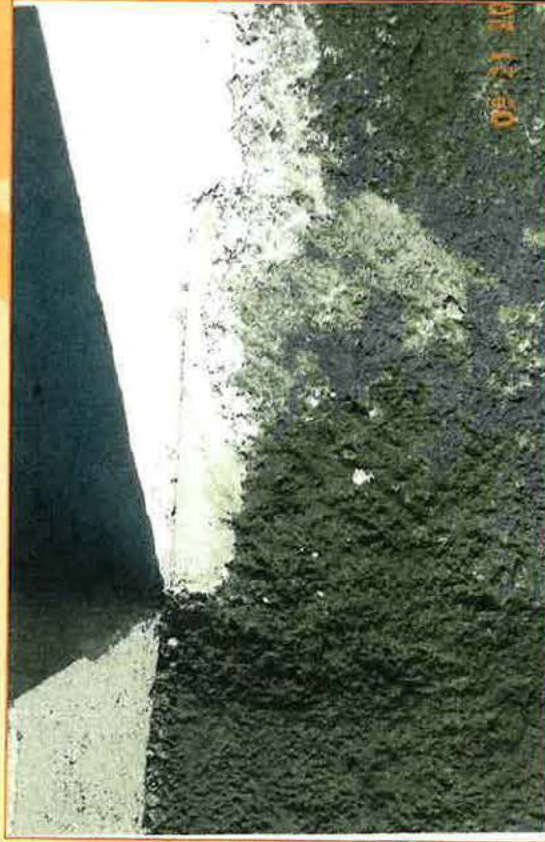
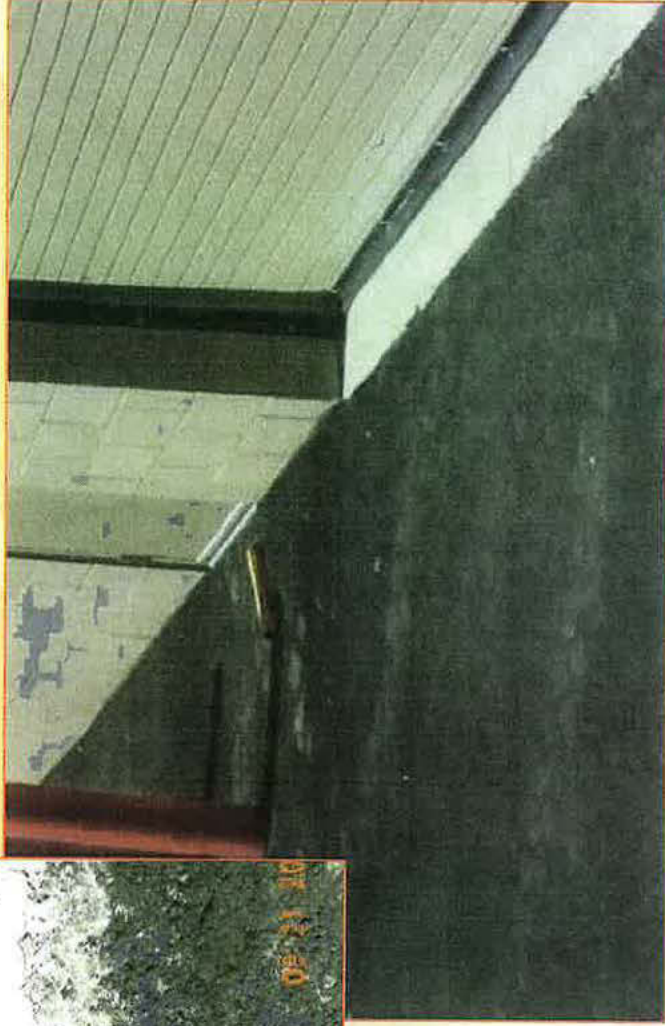
## 1.1 Asphalt Finish Grade -

Construction Documents identify the finish grade to be lower than the interior slab. The as-built condition is above the interior slab.

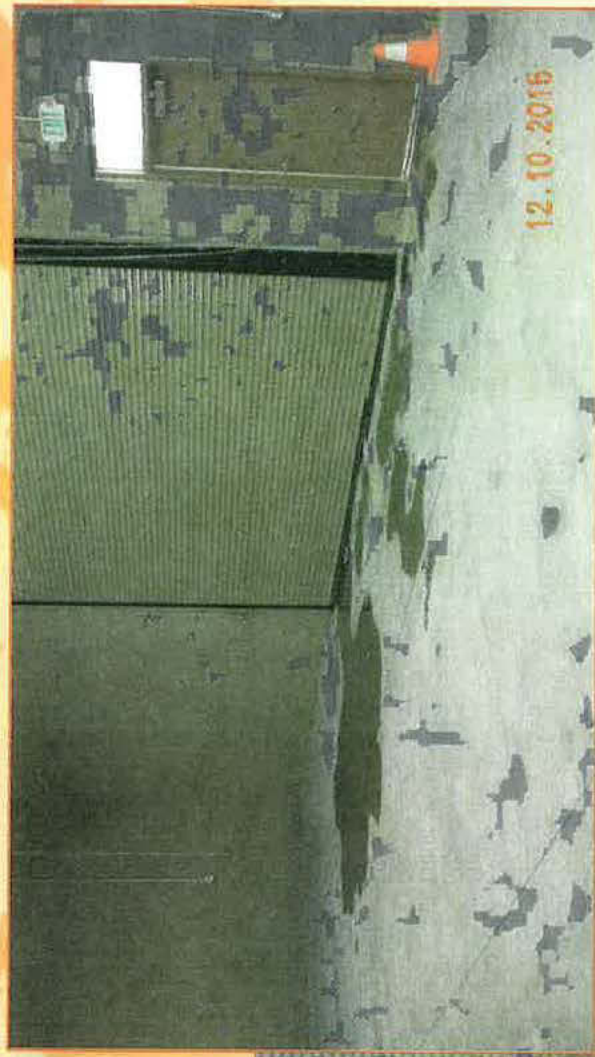
## 1.1 Asphalt Finish Grade -

Construction Documents identify the finish grade to be lower than the interior slab. The as-built condition is above the interior slab.

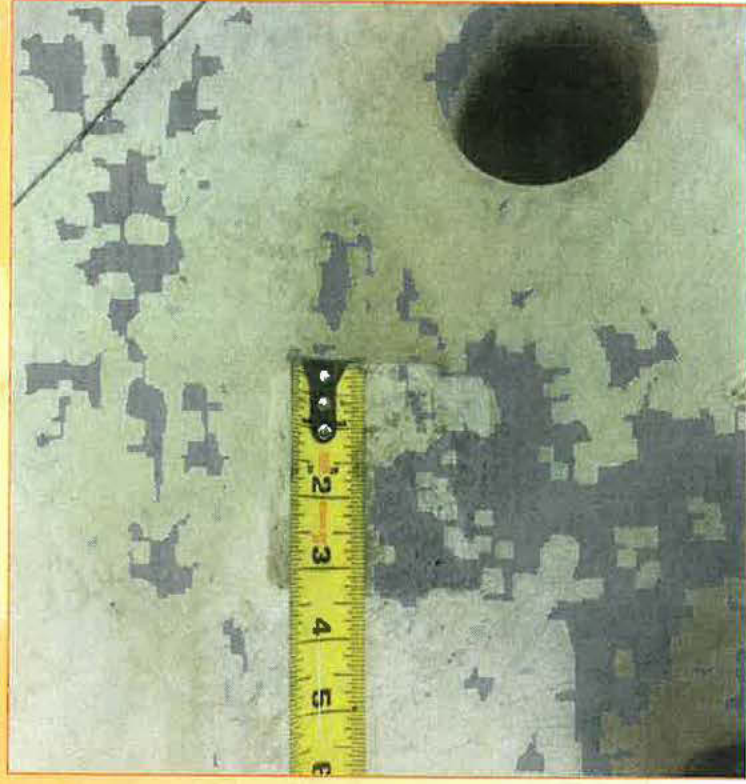
## 2.1 Slab thickness is insufficient -

Construction Documents identify 5" slab in the warehouse area and 4" slab in the office area. The as-built condition, based on concrete removal and core samples is as low as 4" in the warehouse and 2-3/4" in the office.

17.1001	Protect area	HR	24.00	\$42.41
02.1009	Demo office area for slab replacement	EA	1.00	\$7,760.00
02.1013	Provide dumpster for debris removal, 40 yard	EA	4.00	\$750.00

03.5003	Form and pour new 4" slab with 6 mil vapor barrier, as part of a dual pour with greased dowels and key joints	SF	2,286.00	\$13,716.00
03.5005	Additional cost for rebar dowling at 24"oc at building foundation.	EA	242.00	\$51.78

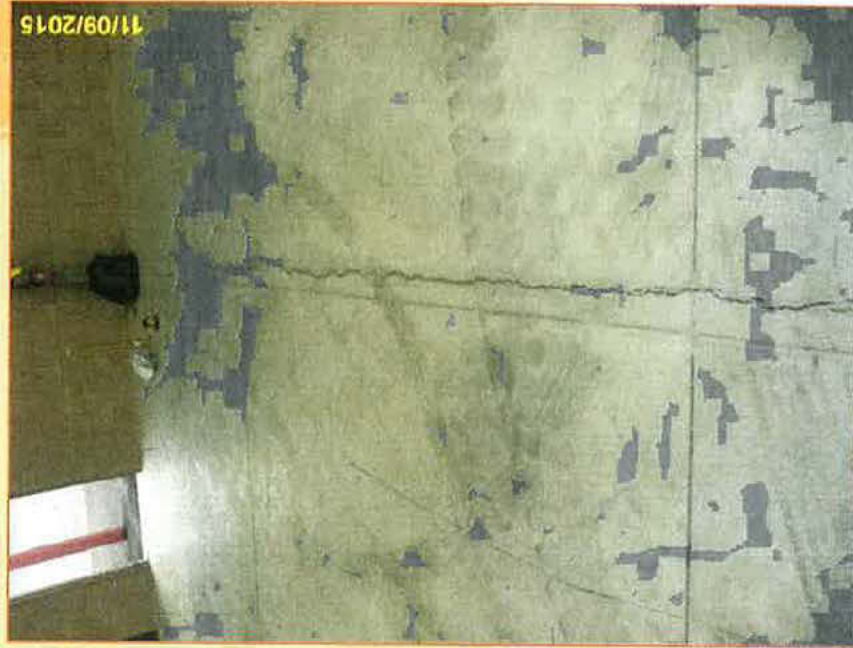
## 2.2 Concrete Pour -

Slab required dual pour with greased dowels with Key-Joints. The as-built condition is a continuous pour, dowels not greased, no key-joint. As-built condition has resulted in large cracks to develop primarily along the building centerline.

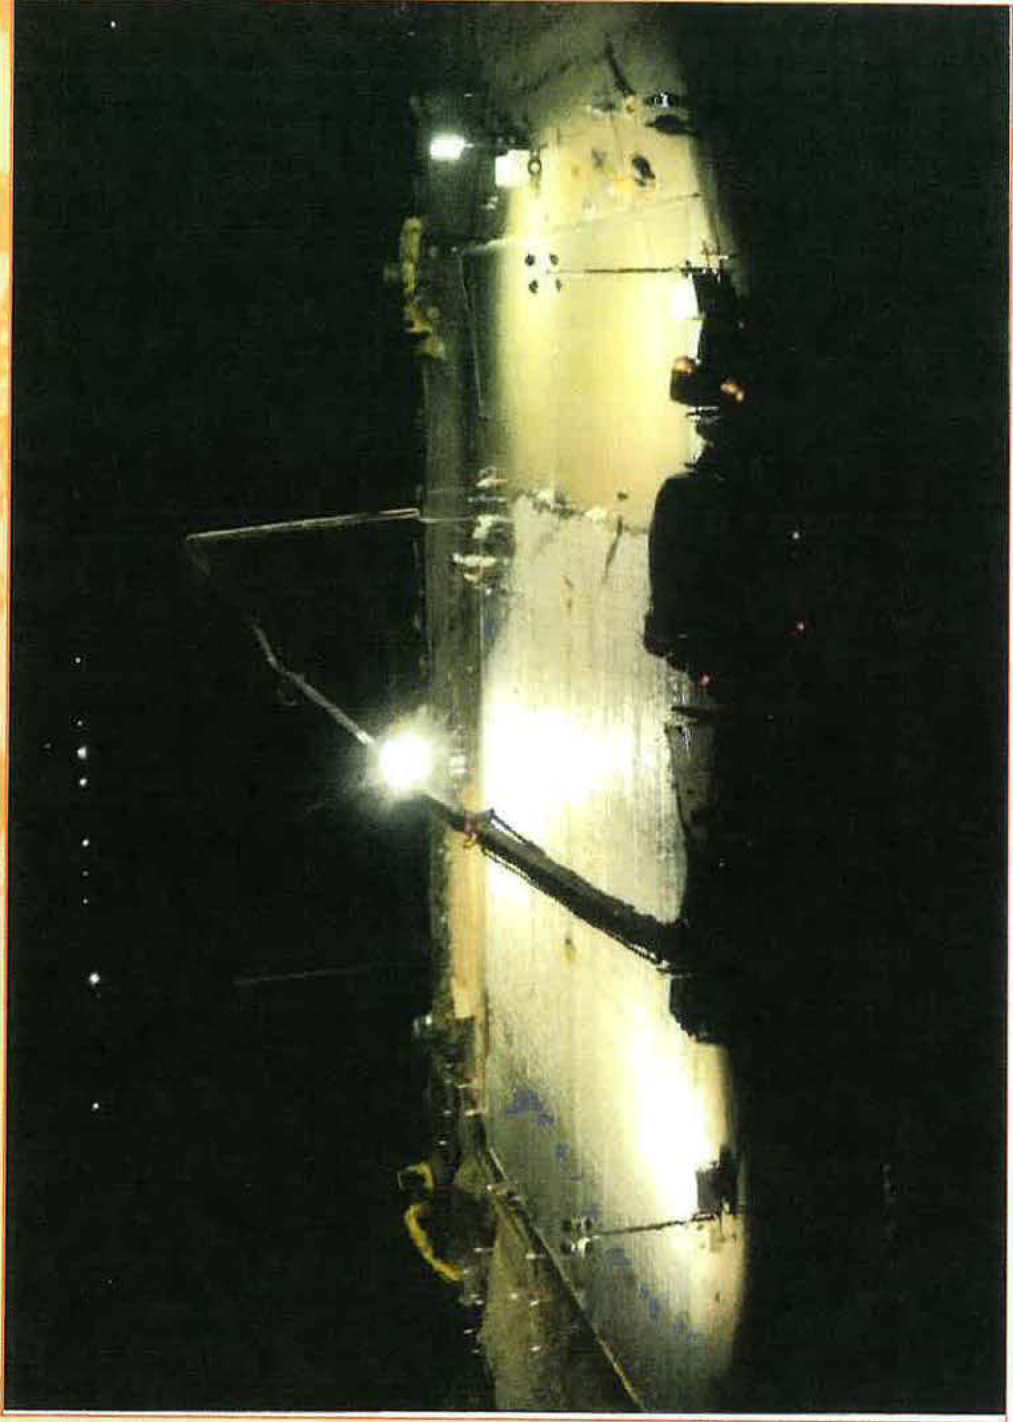
## 2.2 Concrete Pour -

Maximum 3" slump, plasticizers to 8" slump to be provided. The as-built conditions started with 6" slump, some with no plasticizers and water was used.

## 6" Slump

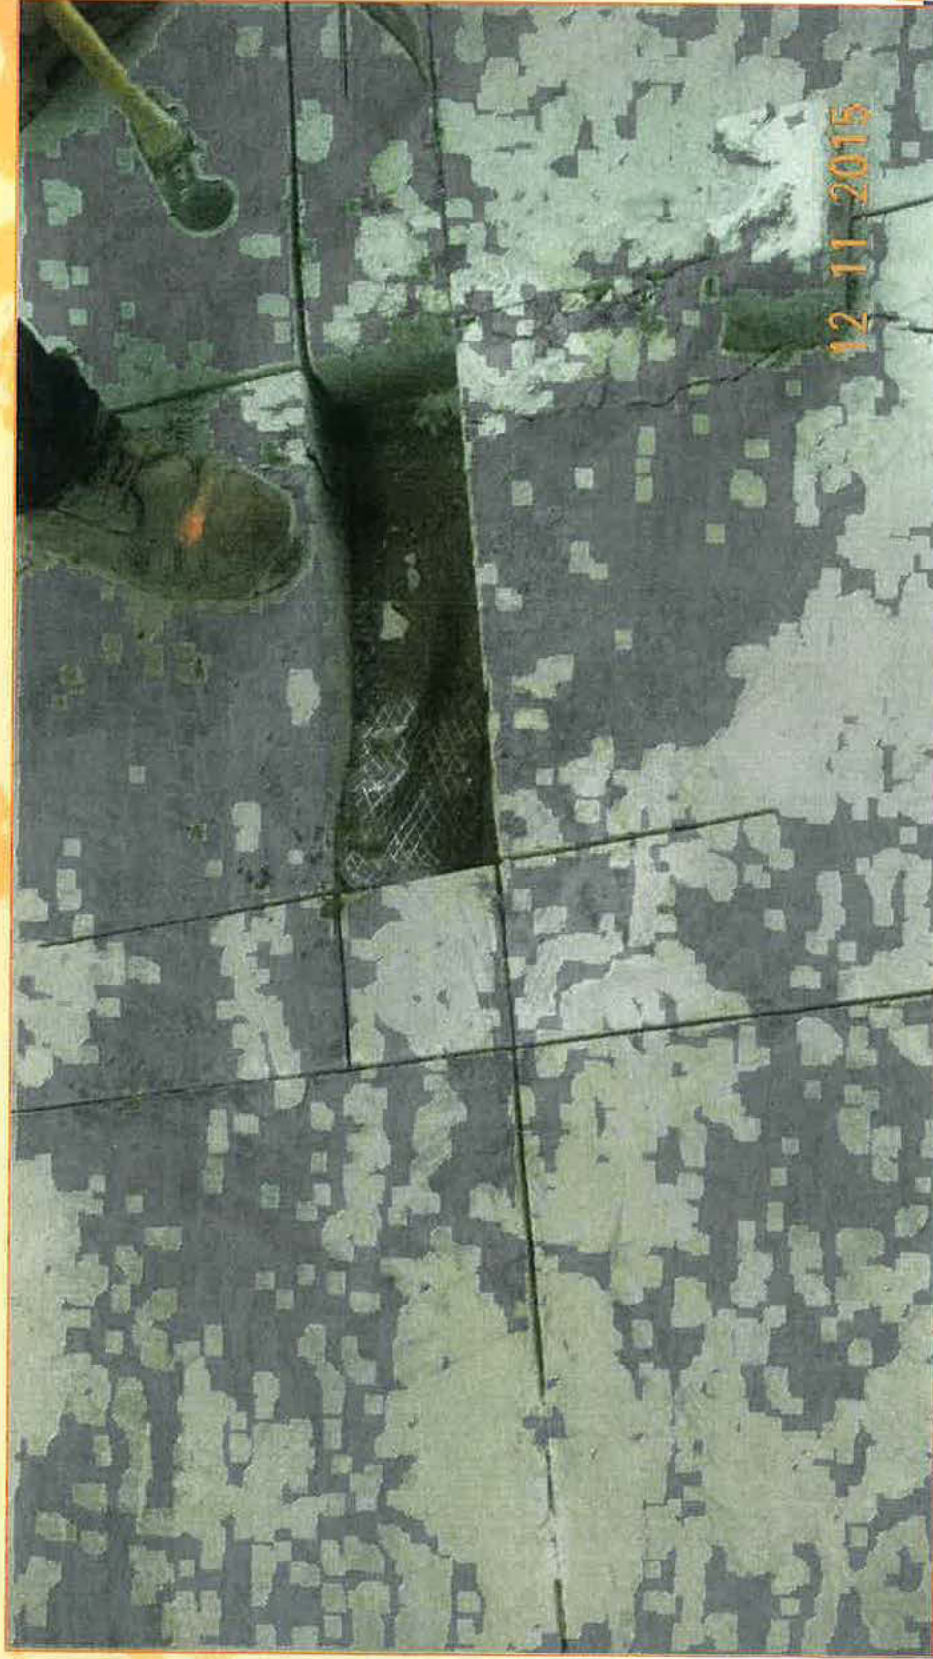
## 2.6 Vapor Barrier -

Per code the vapor barrier is to be a minimum of 6 mil. The existing condition is 2 mil.

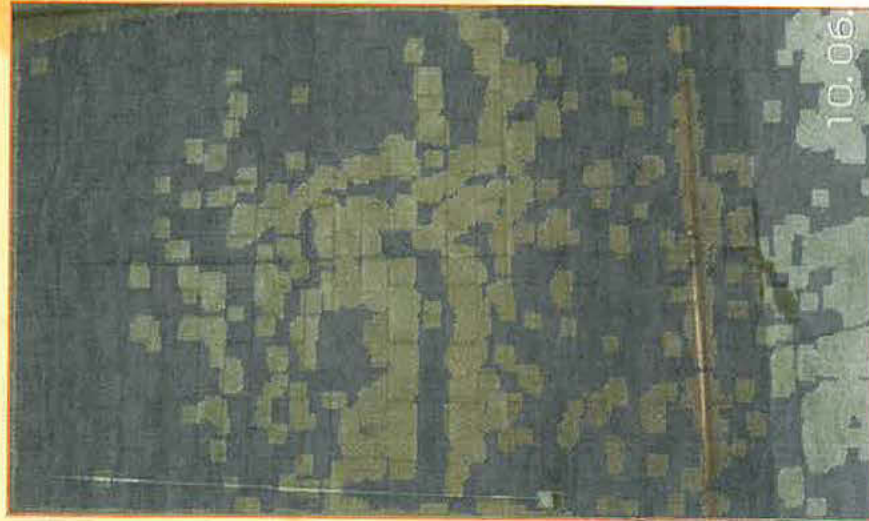
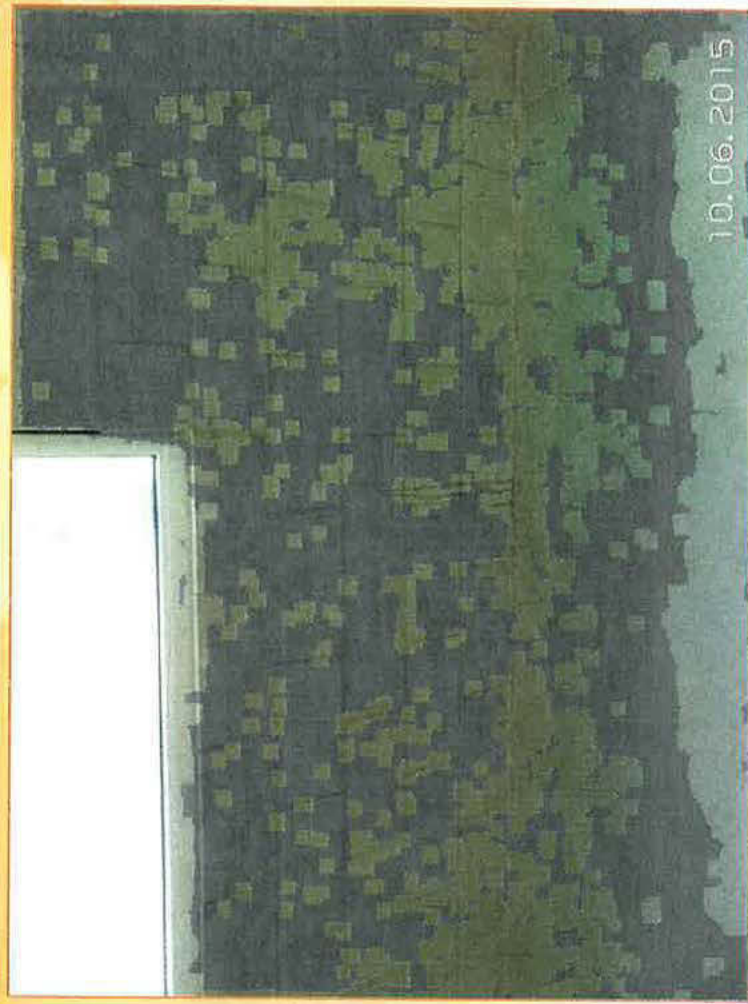
### 3.1 Excessive Cracking/ Water Intrusion-

There are extensive shrinkage cracks within the CMU that is allowing water entry into the building.

<b>Repair Group 1 - 3.1 Excessive Cracking / Water Intrusion</b>				
17.1001	Protect area	HR	40.00	\$42.41
				\$1,696.40
13.0001	Fibwrap the interior and exterior of all masonry walls. Price per Fibwrap Construction Inc.	EA	1.00	\$345,500.00
				\$345,500.00

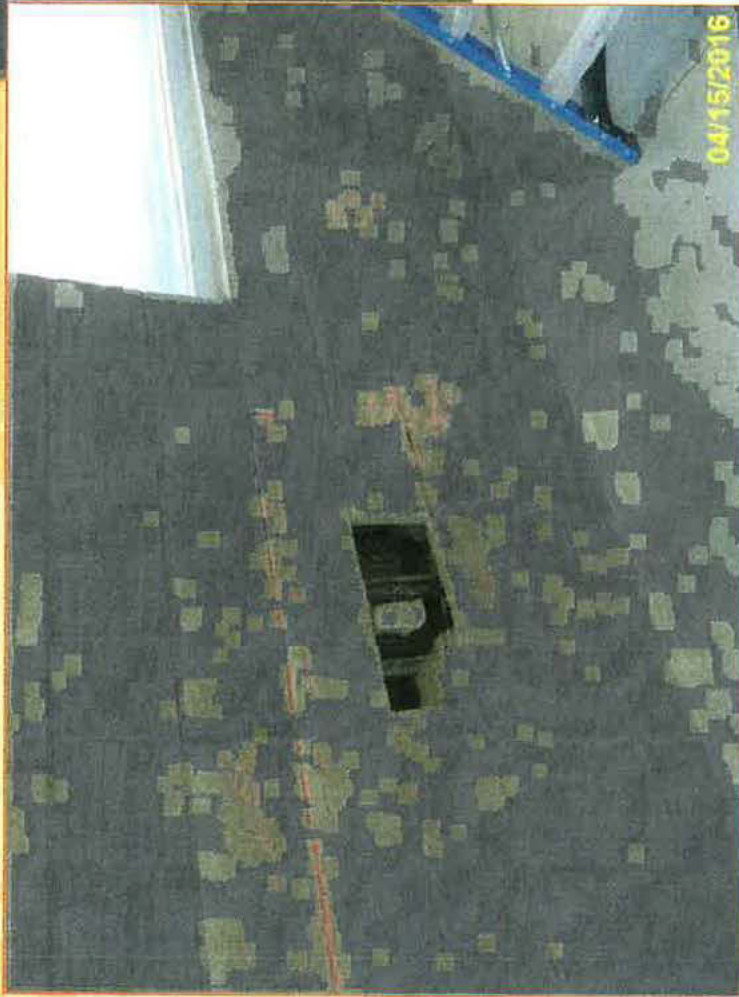
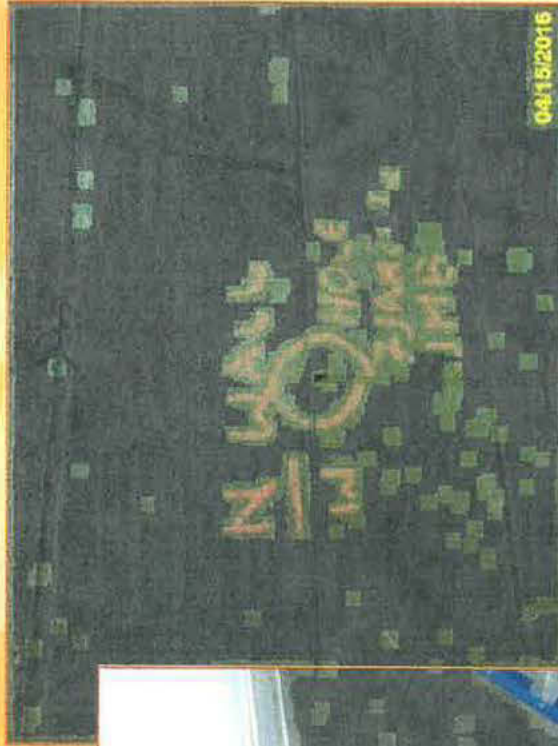
### 3.2 Void in CMU -

There are numerous locations where voids are present within the CMU wall.

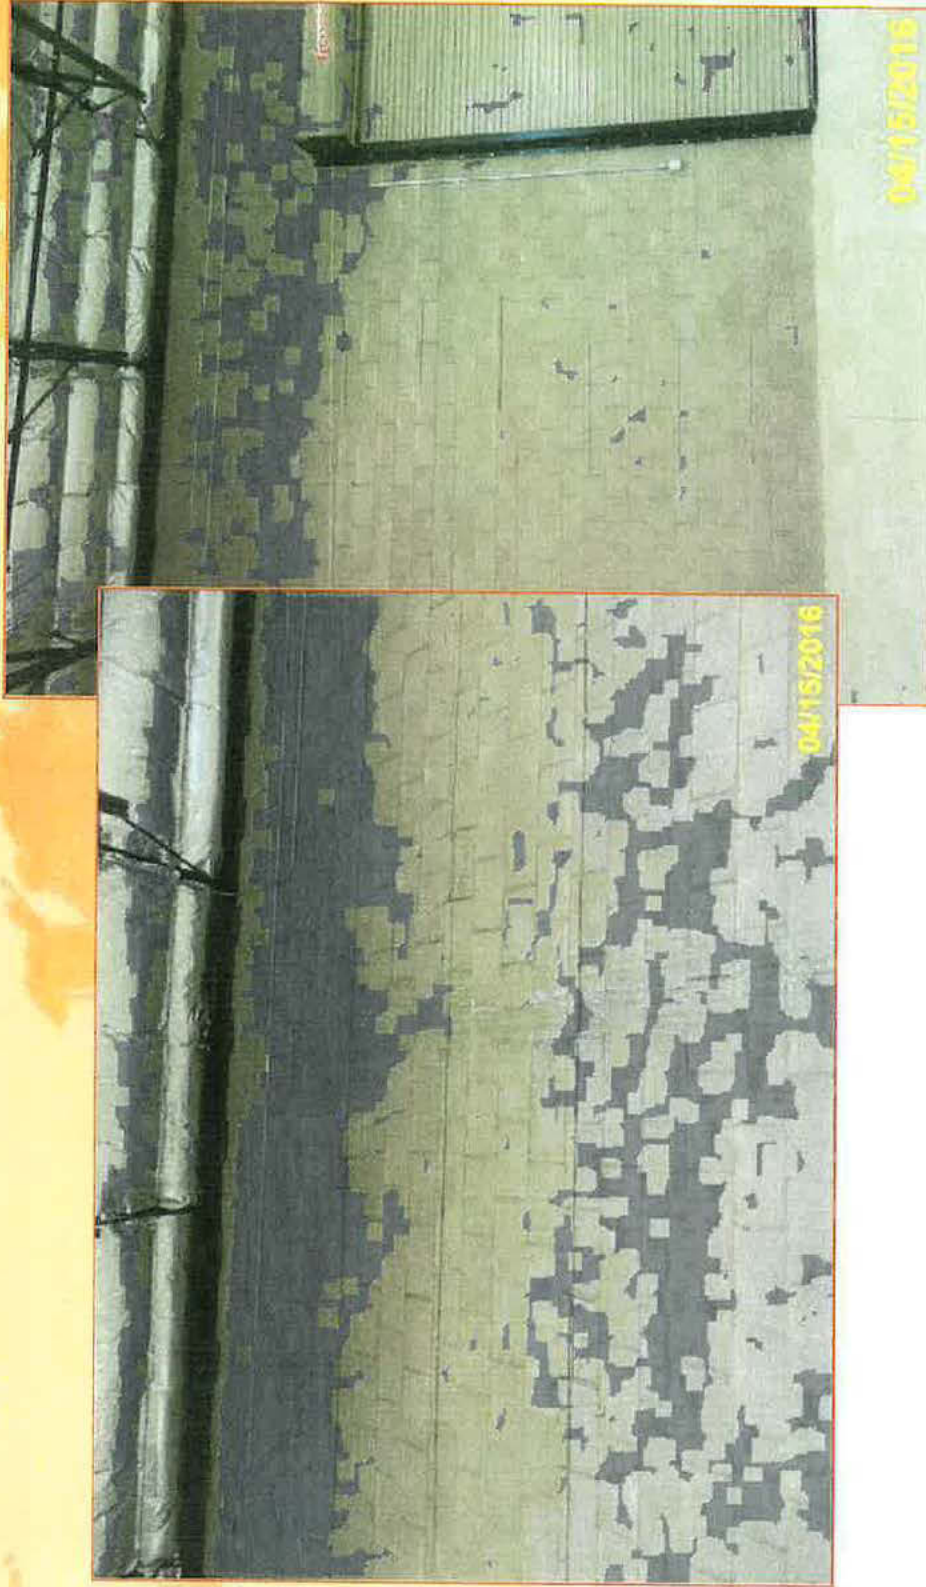
### 3.3 Horizontal rebar spacing -

Construction Documents identify rebar at 24" O.C. The as-built condition is between 24" and 32".

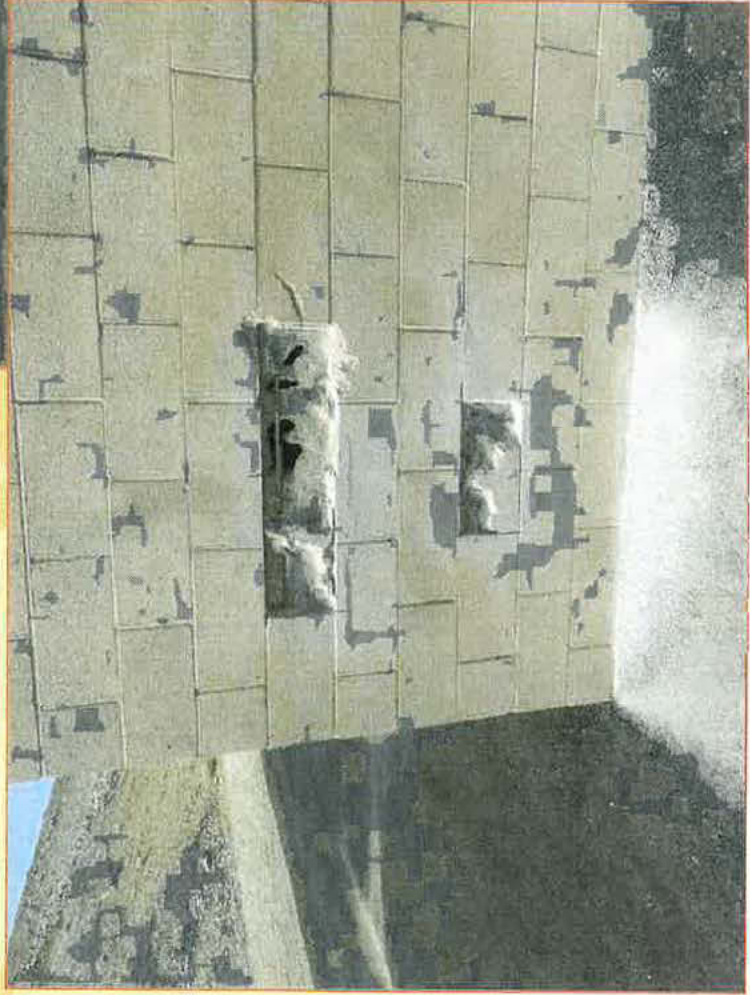
### 3.4 Horizontal rebar lap -

# Construction Documents SD-1 Reinforcing Steel Note #5 and #10 - No built per plans.

10. MASONRY WALLS SHALL BE REINFORCED WITH #5 AT 24" O.C. EACH WAY. HORIZONTAL BAR SPICES SHALL BE STAGGERED.

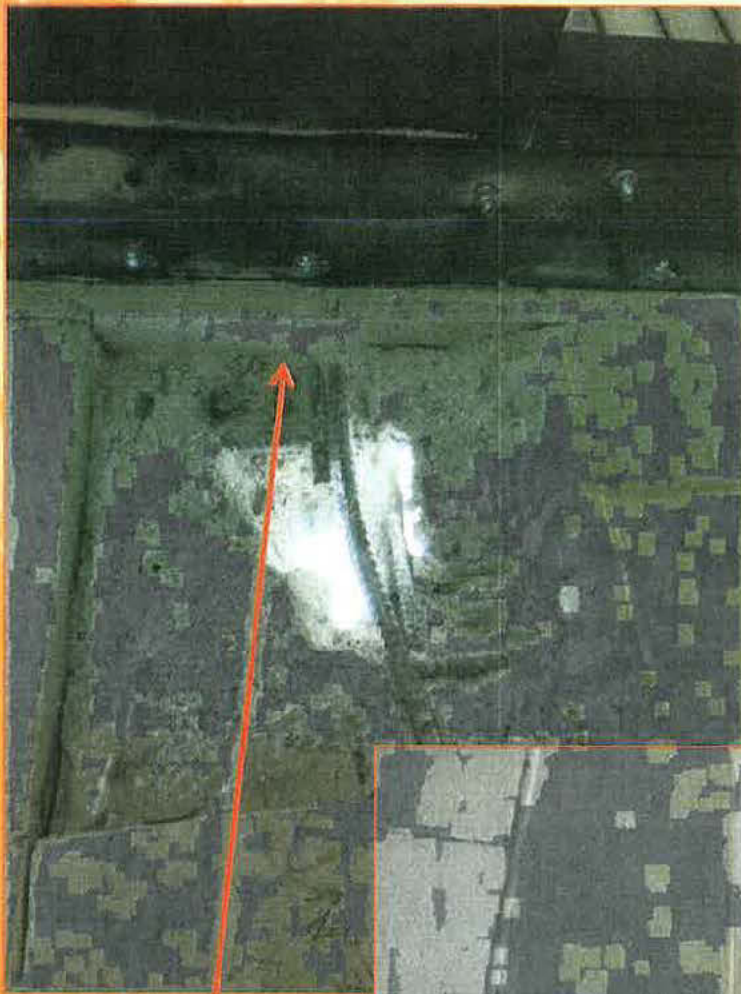
Lintel L-3

### 3.5 Lintel rebar above door-

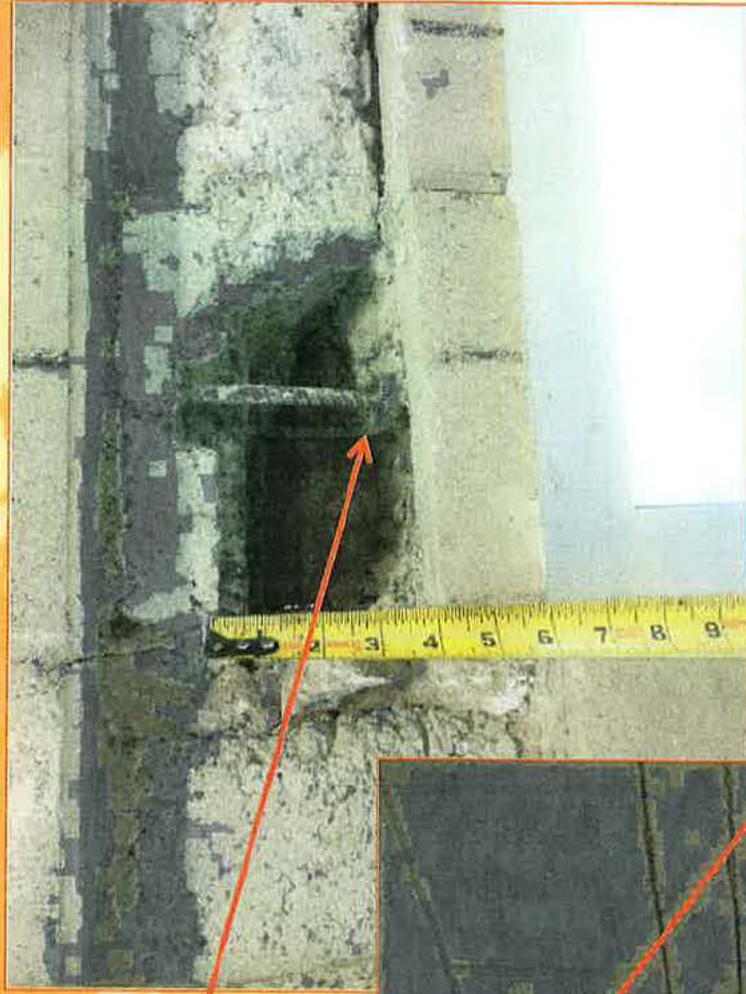
### 3.5 Lintel rebar above door-

Inadequate Cover

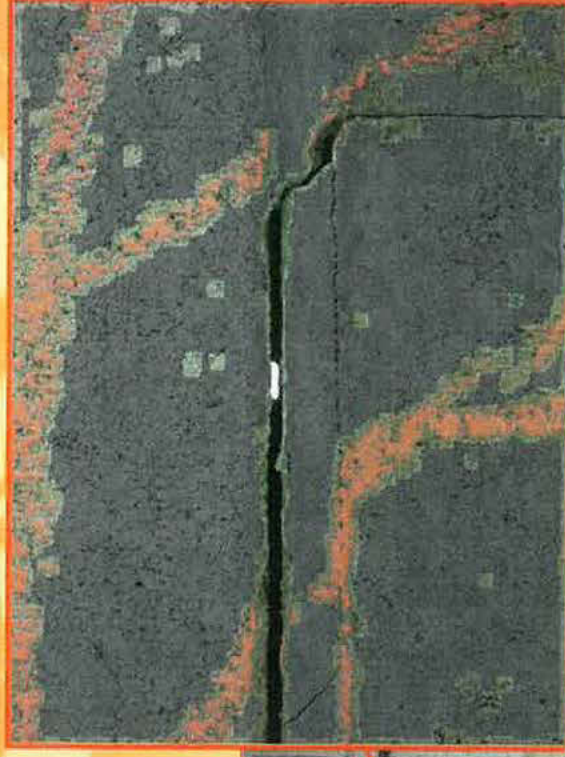
### 3.6 Stair step cracks -

At door, extending to roof, likely the resultant damage due to items listed previously. At some cracks, daylight is visible.

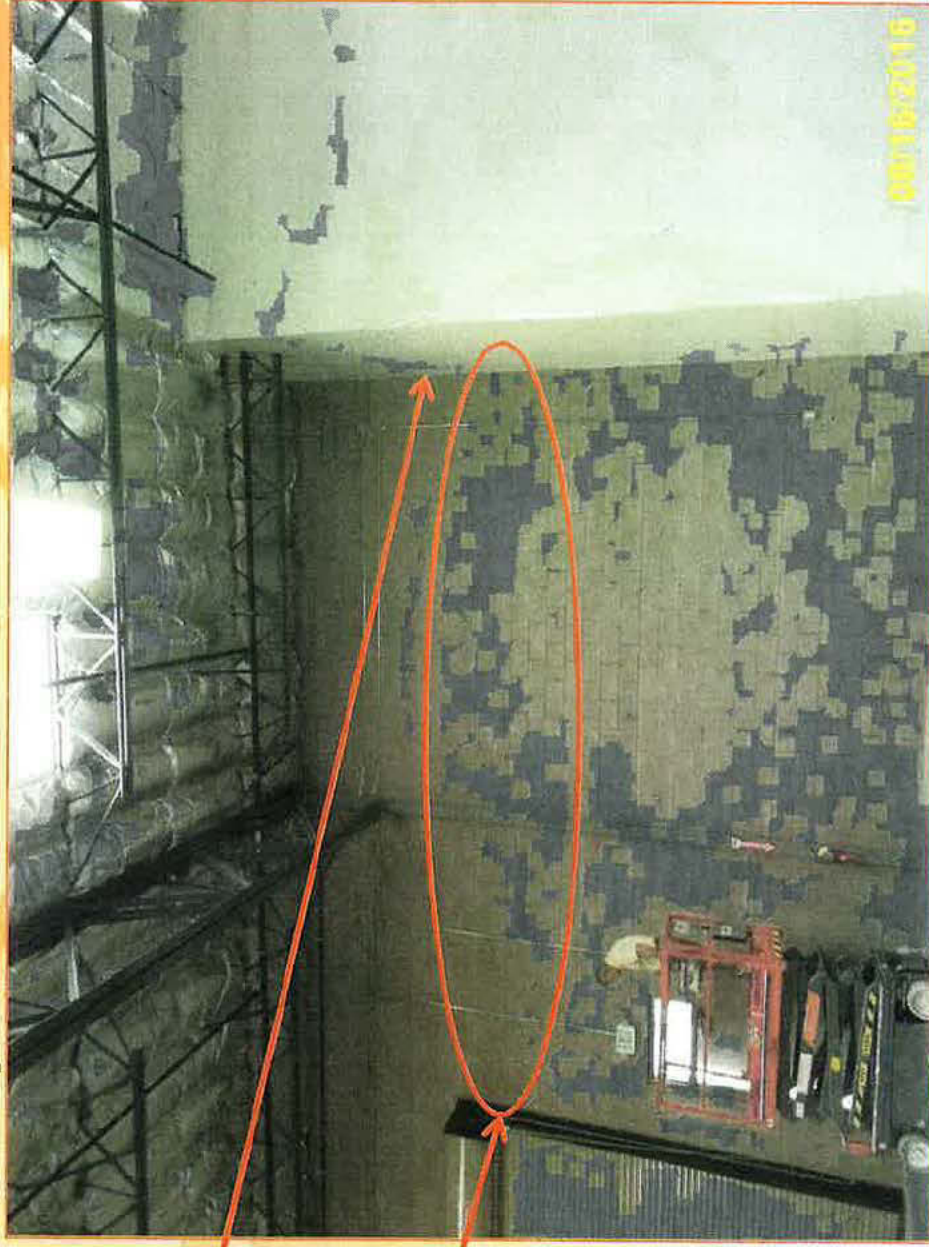
No distress at Fire  
Command Room

Area of wall  
bowing inward up  
to 1-1/4"

### 3.7 Wall not plumb – NEW ITEM

West CMU wall up to 1-1/4" out of plumb

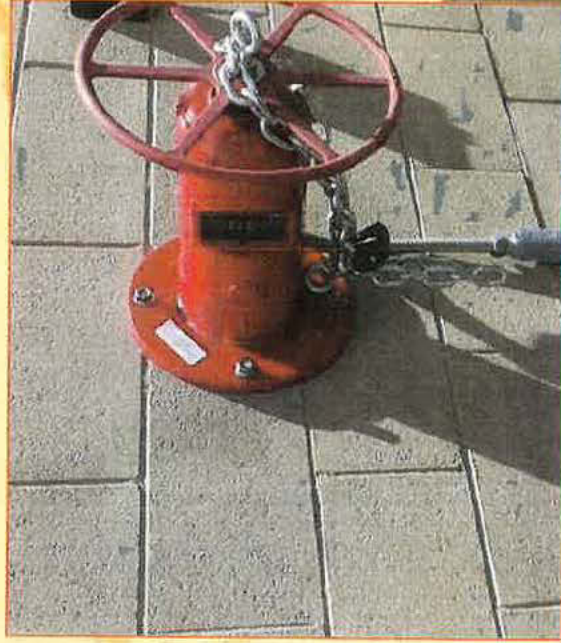
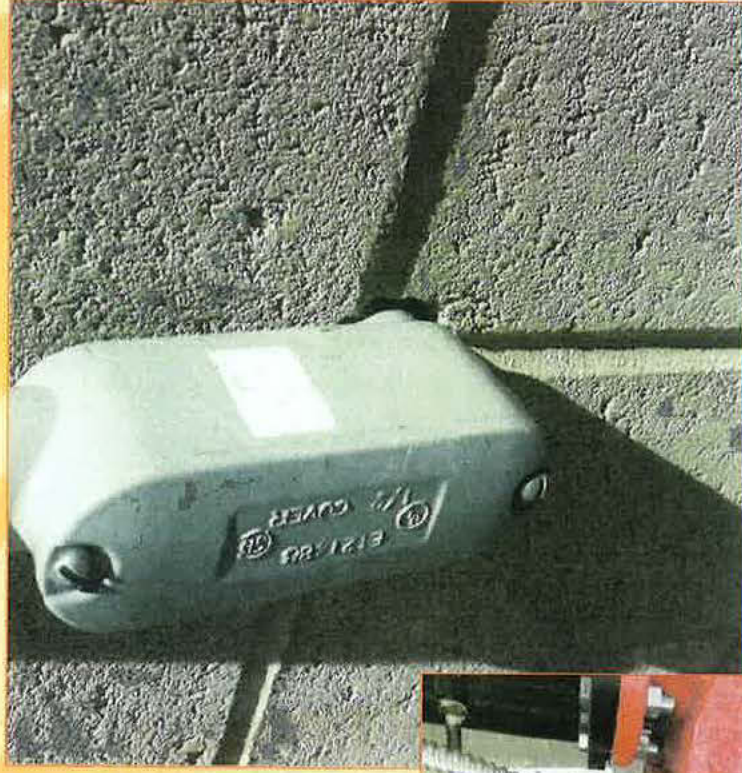
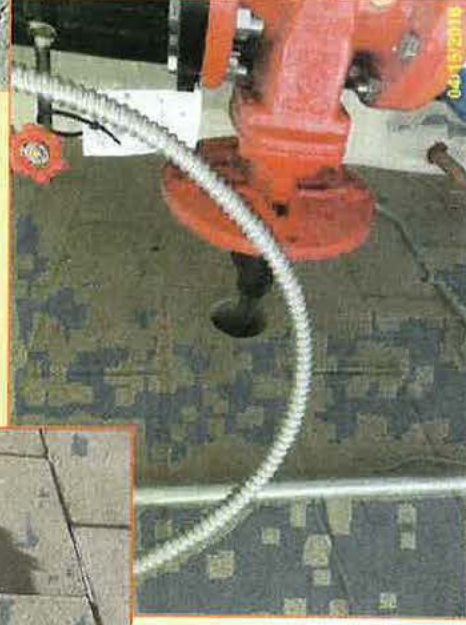
#### 4.1 Penetrations not sealed -

Exterior wall penetration are required to be sealed from the outside with backer rod and sealant.

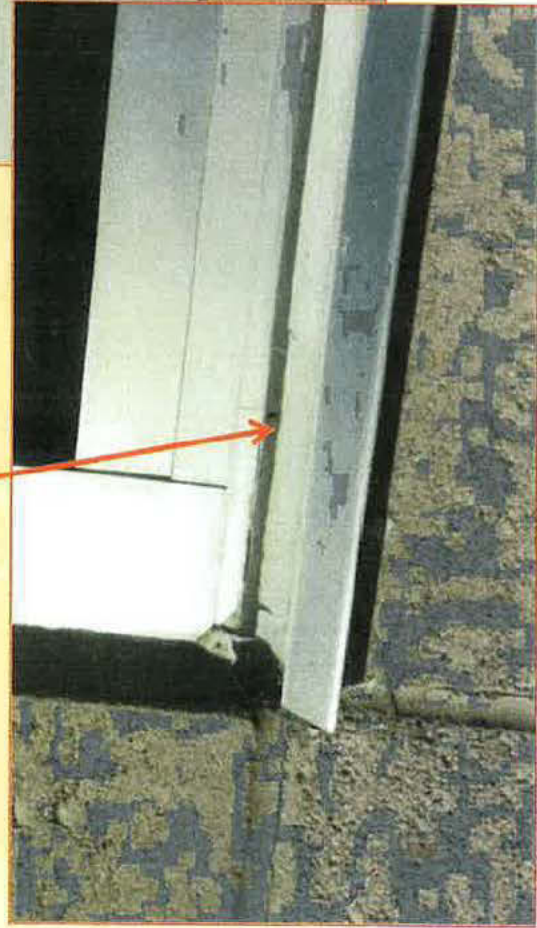
Construction Documents identify exterior sill flashing. The as-built condition includes a "Beauty Trim" opposed to sill flashing.

Beauty trim added-  
Sealant covers  
weep holes

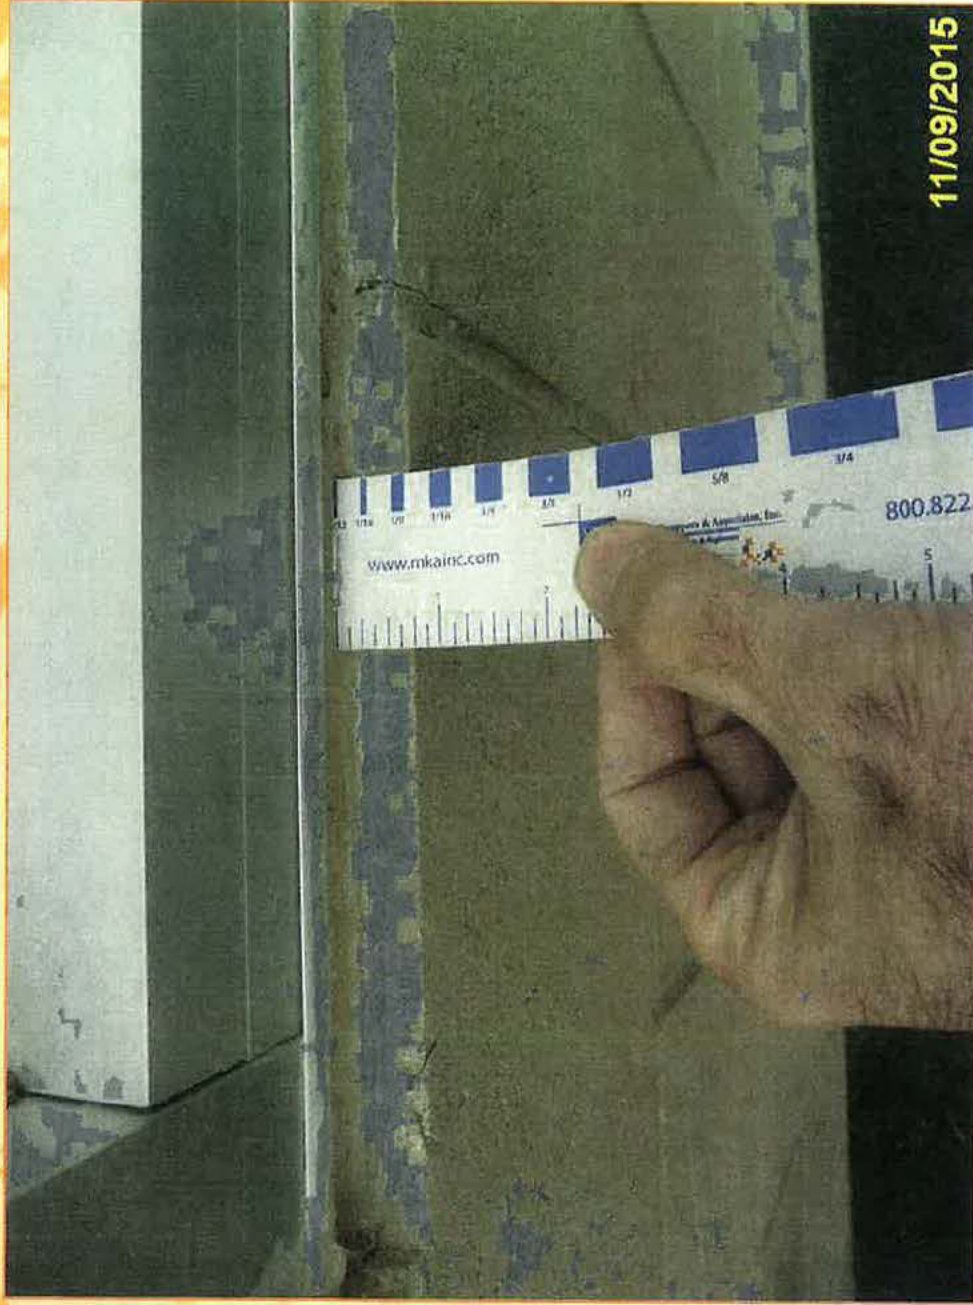
### 6.3 Windows not flush to outside block

# Construction Documents A8.1 Detail 3 & 4 - Not Built per plan

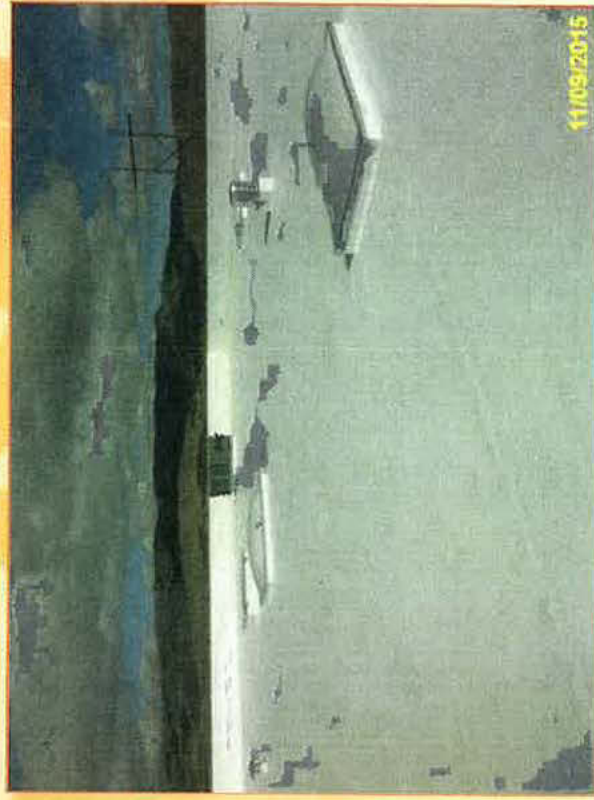
## 8.1 TPO Roofing (see A2-2)-

Installed TPO in place of roofing specified without approval from owner or building department.

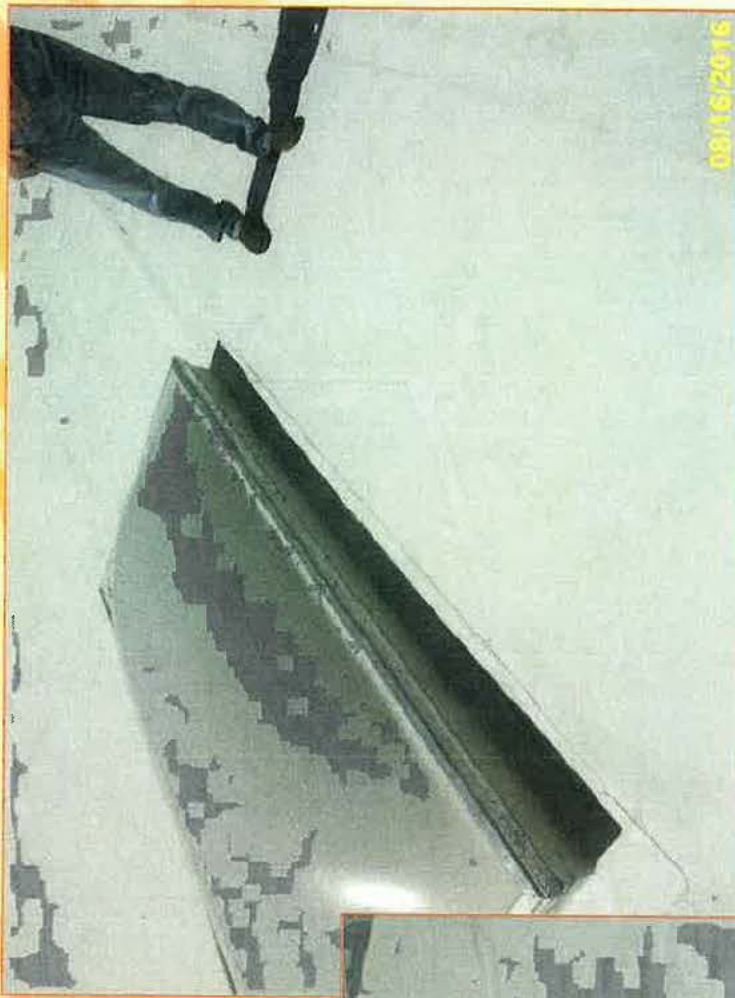
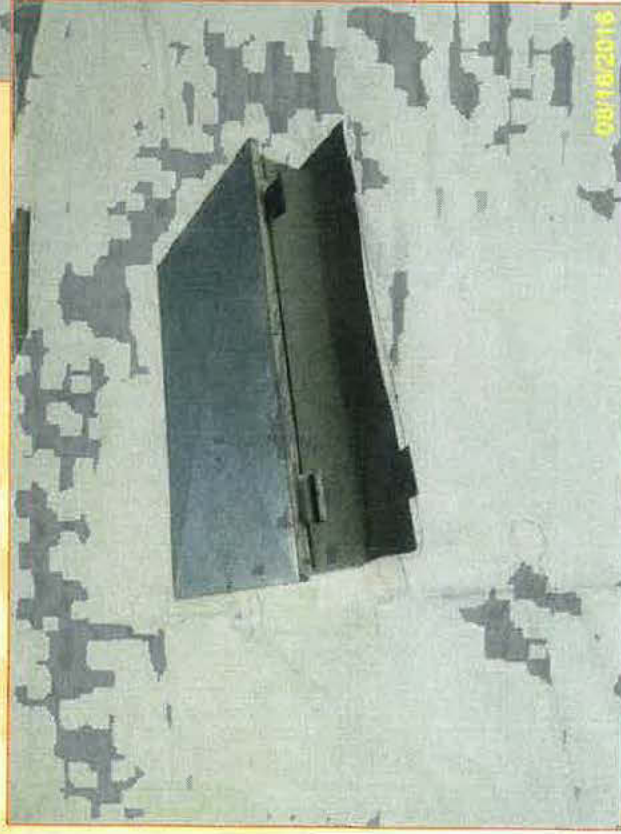
## 8.2 Crickets -

Missing crickets at all skylight and mechanical unit curbs.

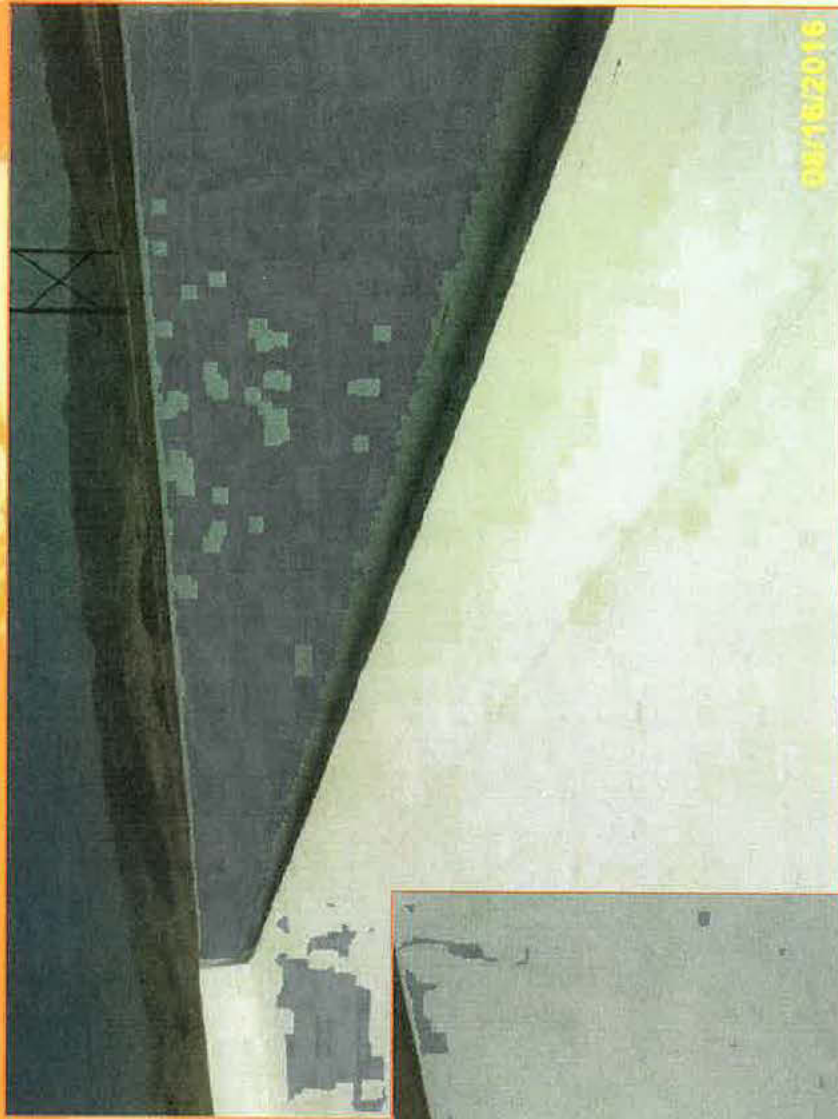
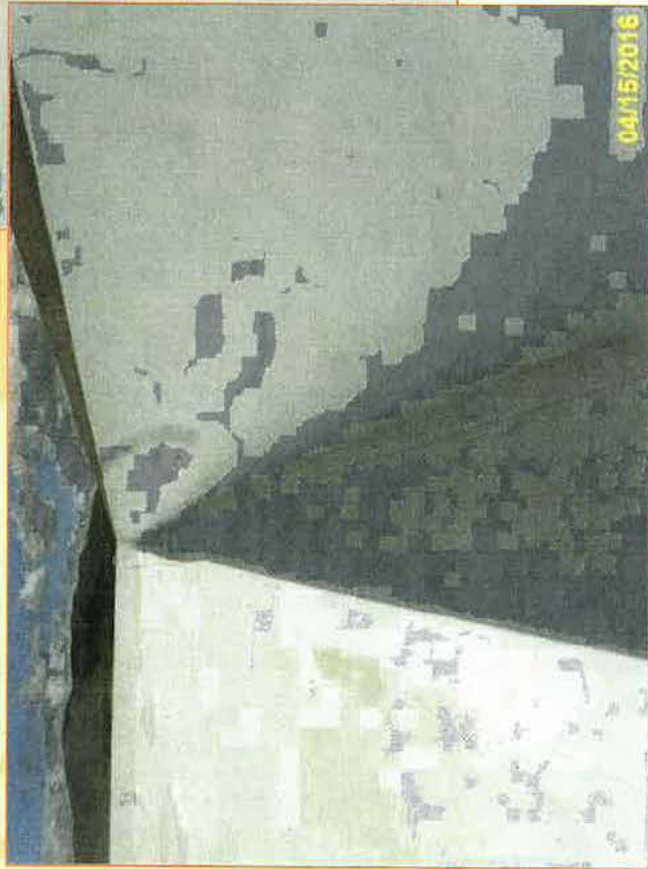
## 8.4 Cants -

Missing cants where specified.

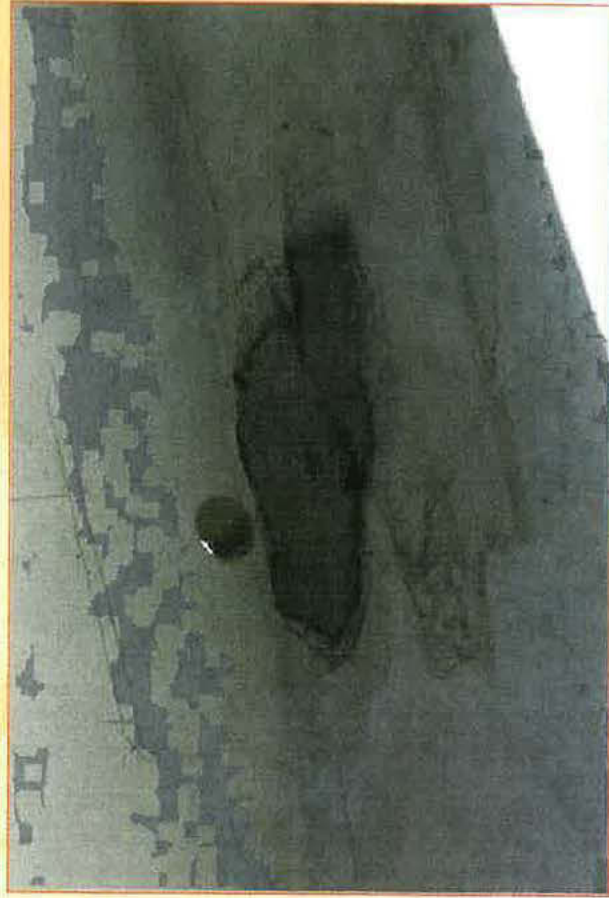
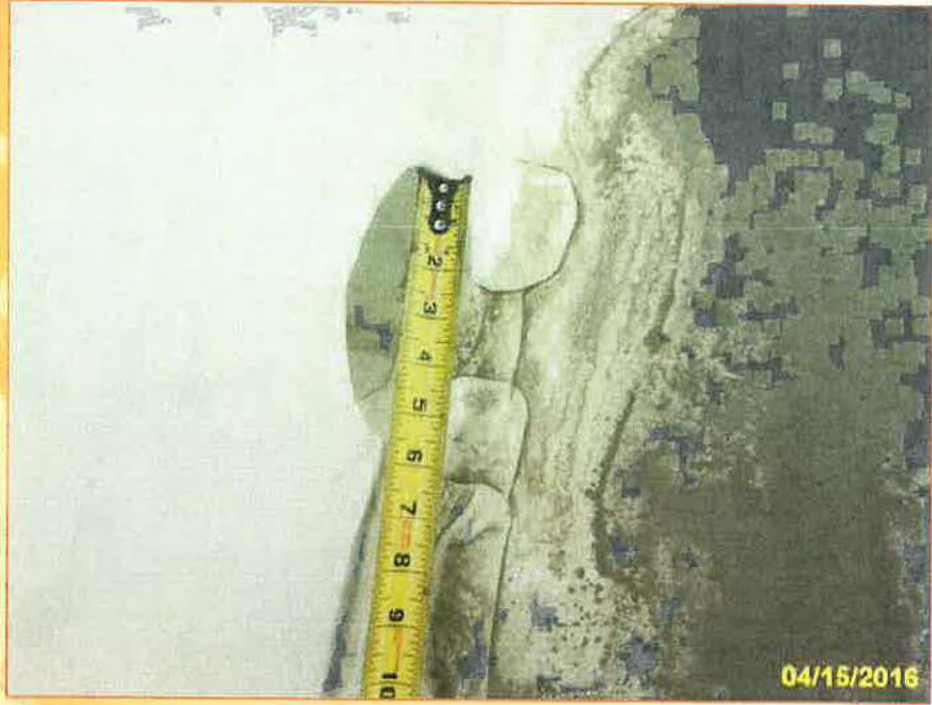
## 9.2 Scuppers -

Construction Documents identify 8" x 8" metal scupper. The as-built condition is 5 1/2"

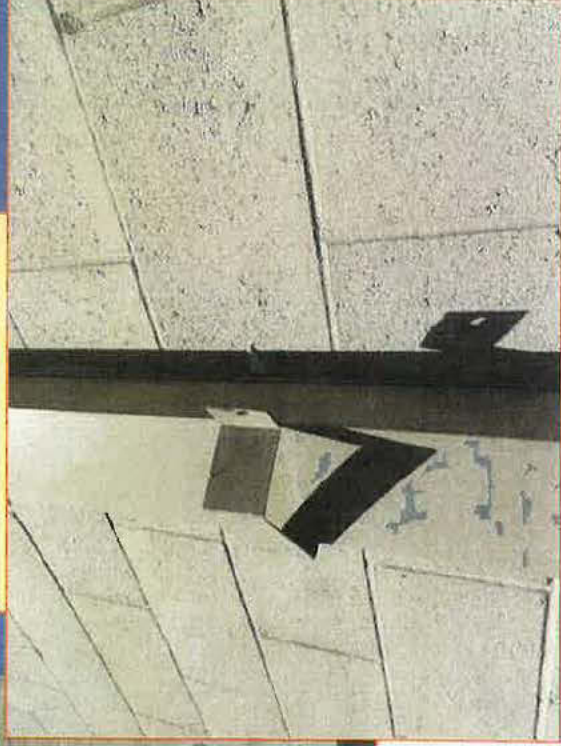
### 9.3 Downspouts -

Construction Documents identify cut-out at downspout and tie down straps at 6' centers. The as-built conditions does not have cut outs and plastic anchors are not sufficient.

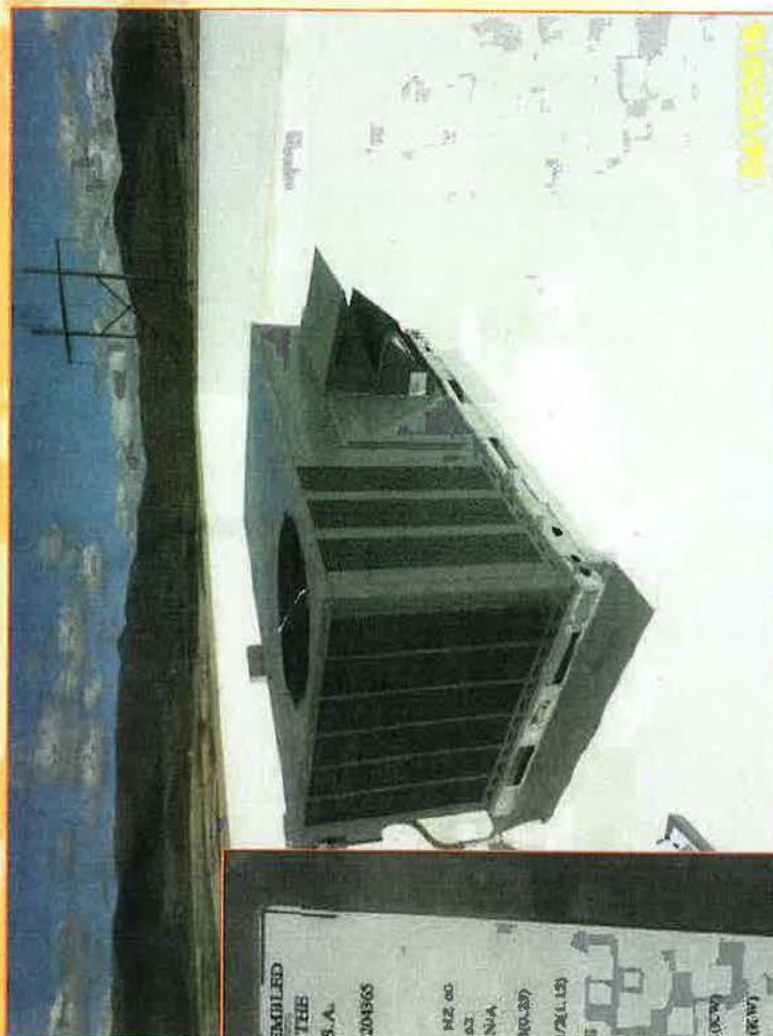
Contract identifies all material to be new. The as-built condition includes units that were manufactured in March 2012, 2 years and 8 months old when installed.
