Commissioners' Meeting Agenda Item Request  
Date of Meeting: 03-21-17

Stormo Investments v. Dennis Banks Construction  
Plaintiff Cost of Repair

**Plaintiff Cost of Repair  
Estimate Summary Report**

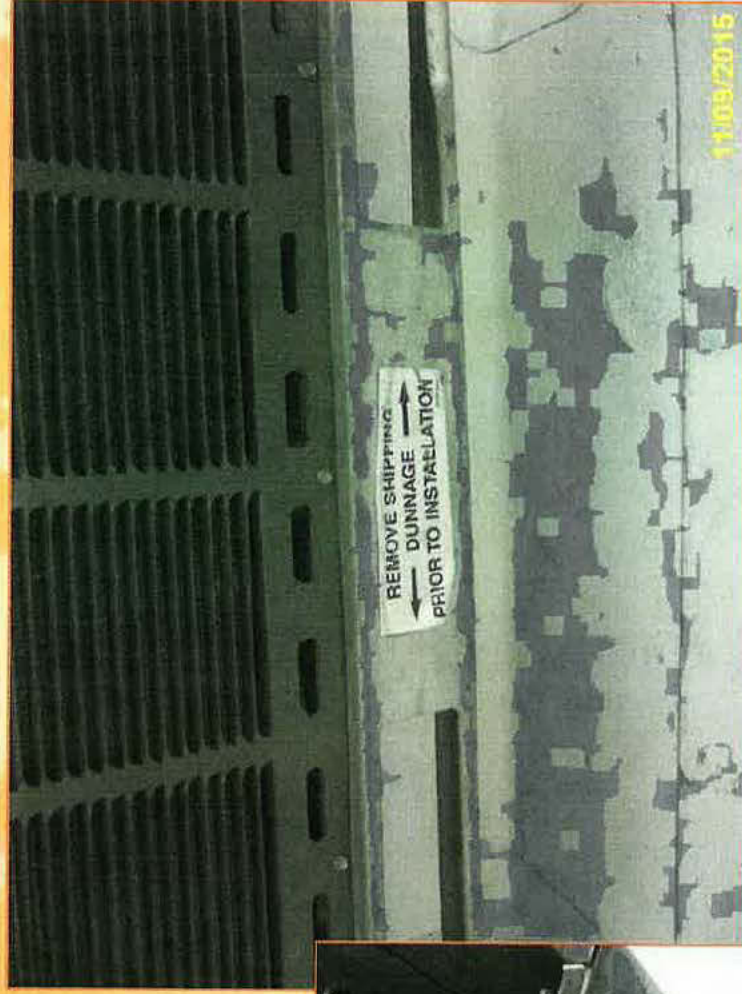
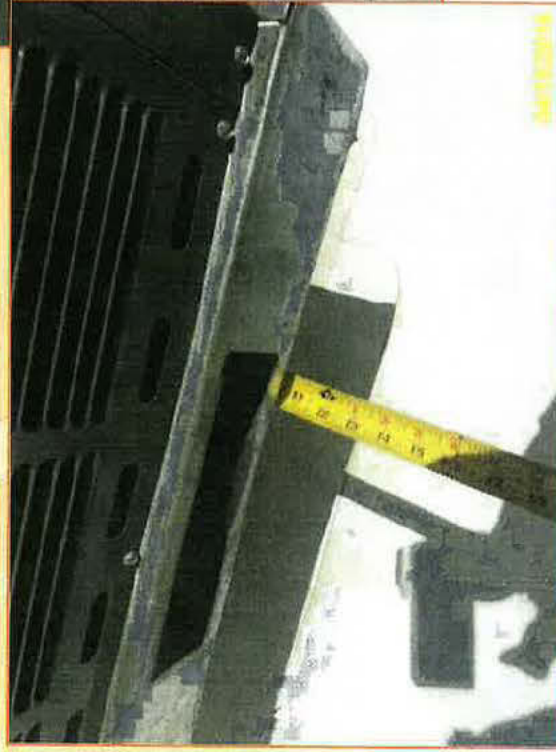
## 12.2 Units are still sitting in the shipping pallet -

The as-built condition is not per the manufacturers installation instruction

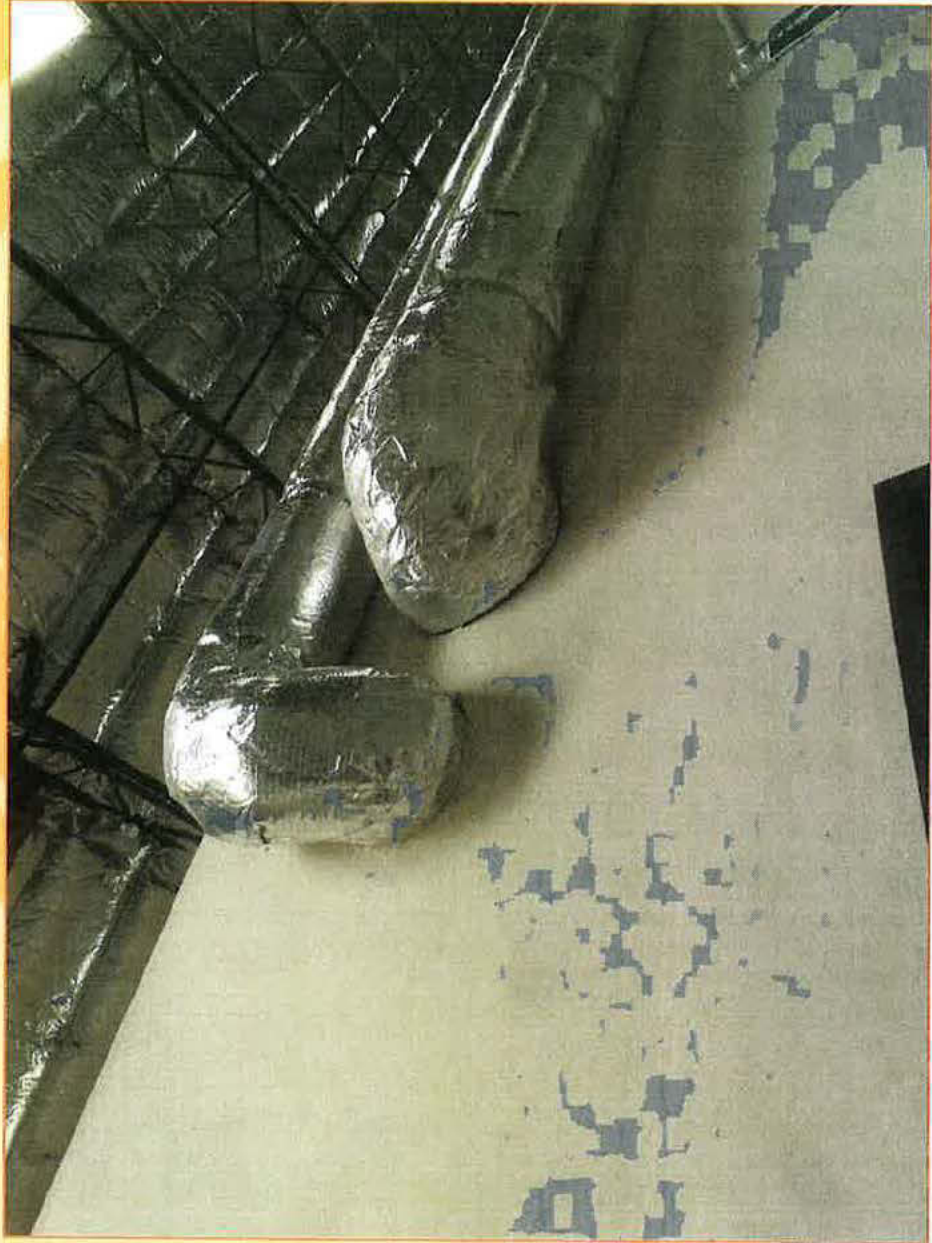
## 12.4 Fire rated caulk required at A/C vents in 1 hour wall -

Code requires fire rated caulking where required. The as-built condition does not have caulking to meet code.

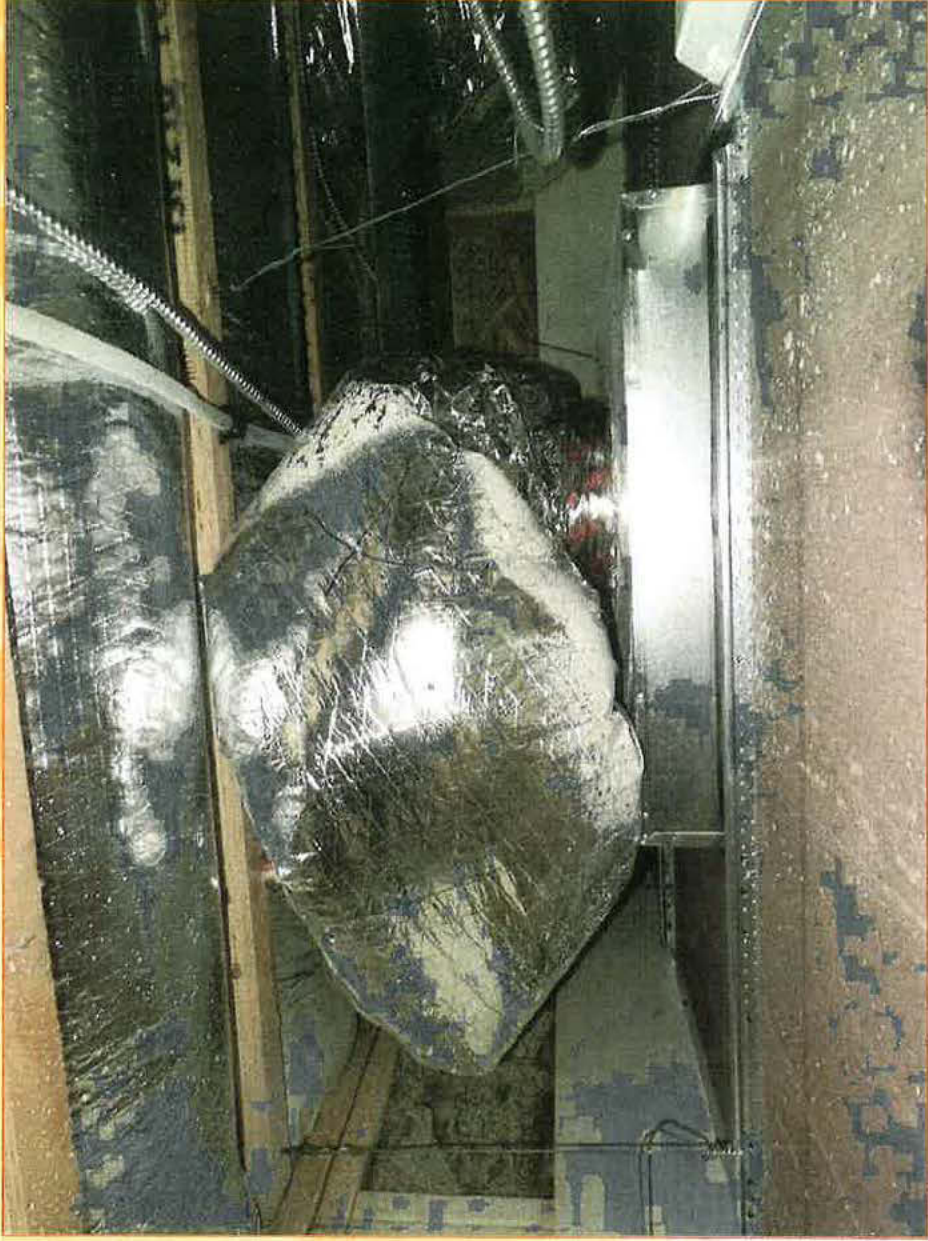
## 12.5 Bent and Deformed Ductwork -

Flexible ductwork is bent, twisted and deformed, restricting airflow to areas of the office build-out.

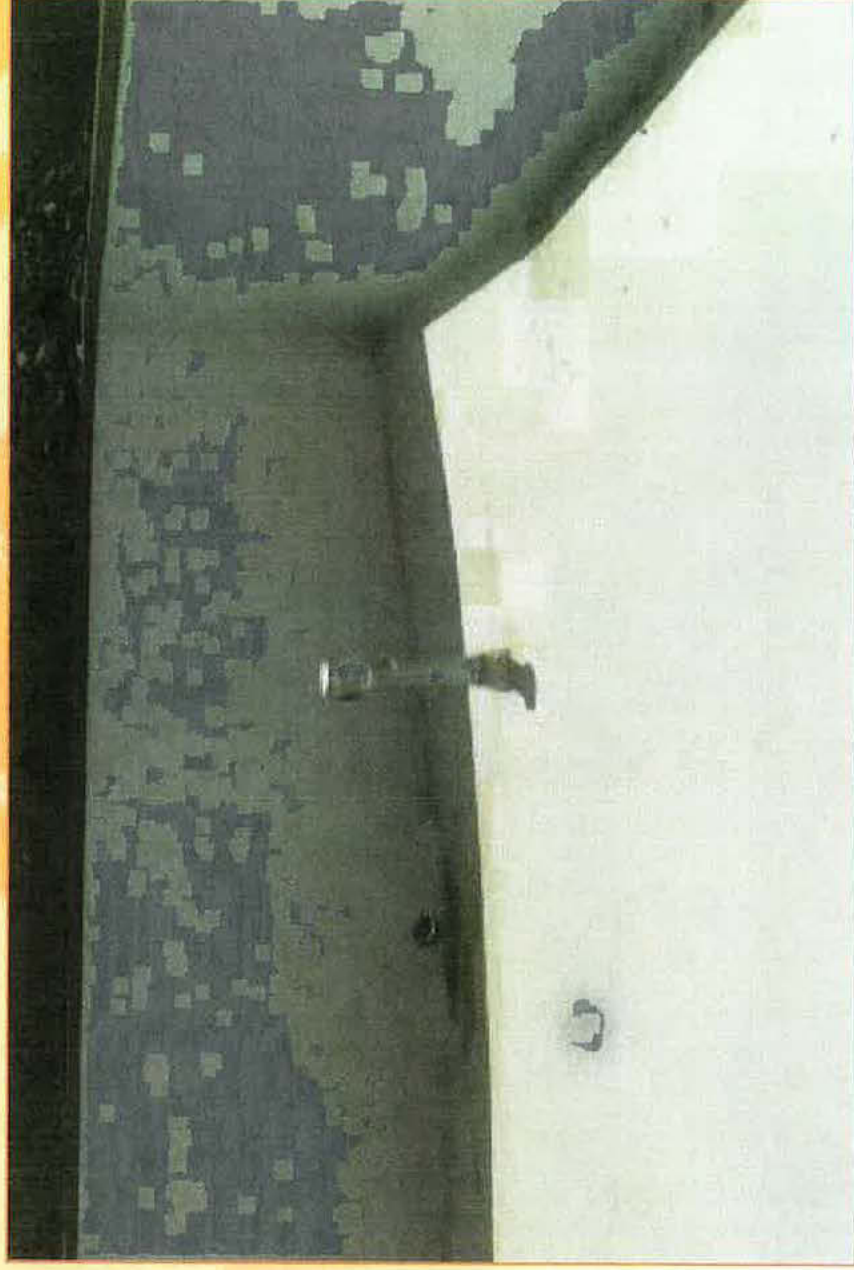
## 12.6 Heater vent pipe clearance -

Vent pipe does not have adequate clearance to adjacent parapet walls.

**802.5 Type L vent terminations.** Type L vents shall terminate not less than 2 feet (610 mm) above the highest point of the roof penetration and not less than 2 feet (610 mm) higher than any portion of a building within 10 feet (3048 mm).

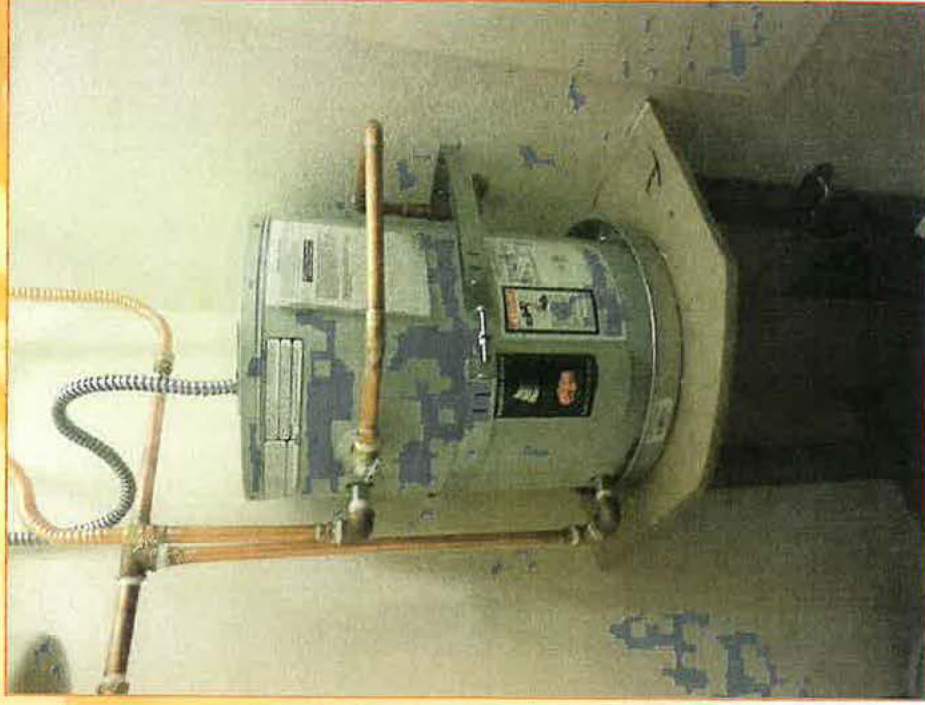
### 13.1 Undersized water heater installed -

1500W water heater installed in lieu of specified 2500W unit.

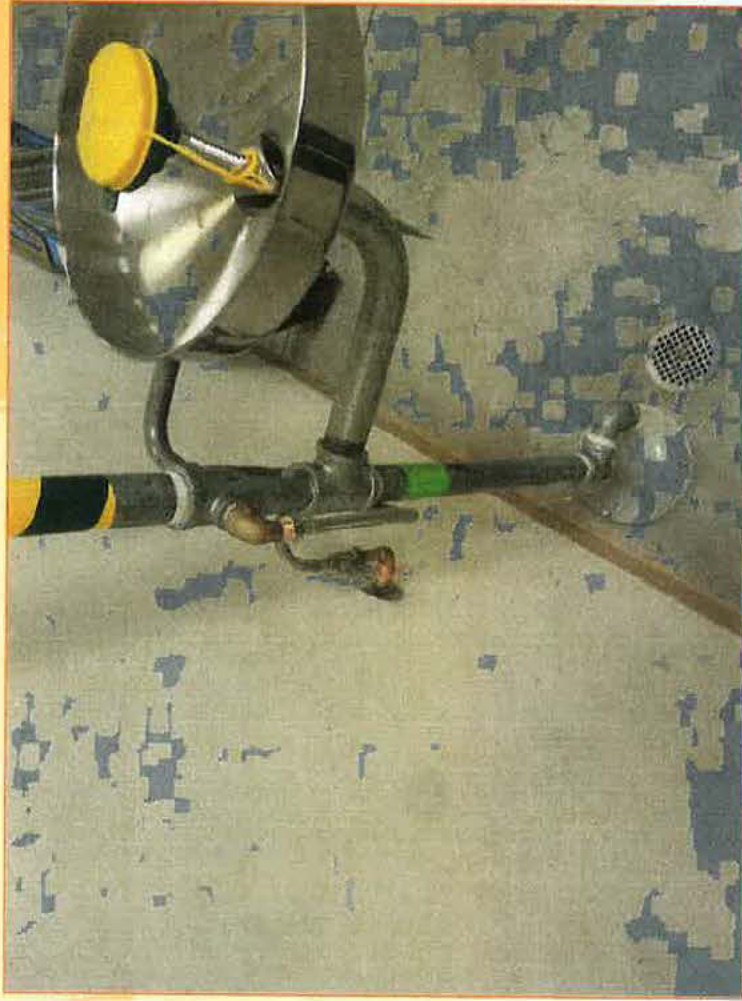
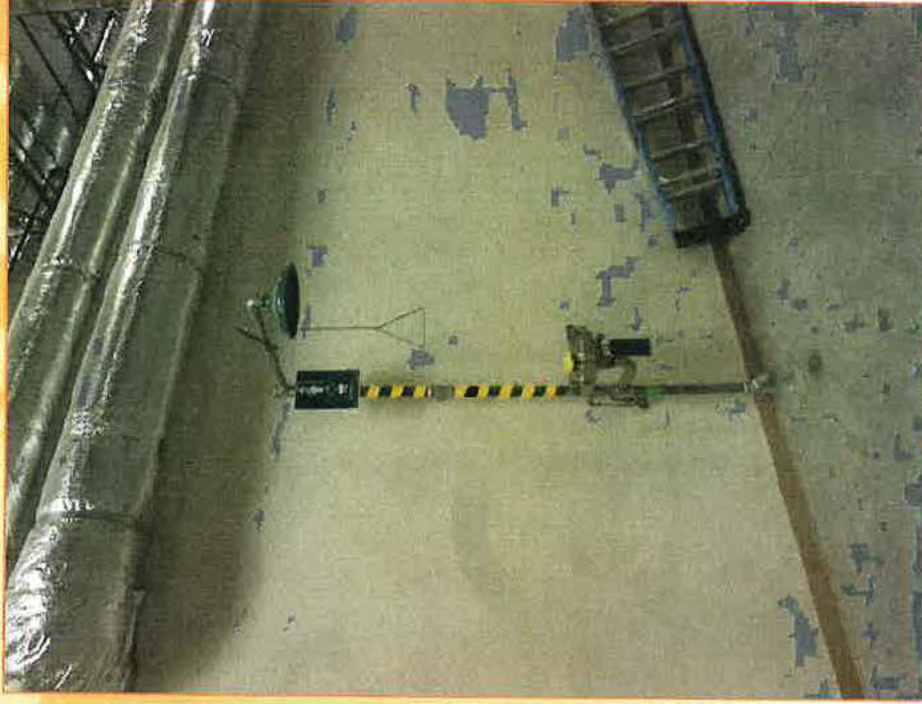
### 13.2 Emergency eye wash/shower -

Manufacturer requires tepid water. The as-built condition only cold water is supplied.

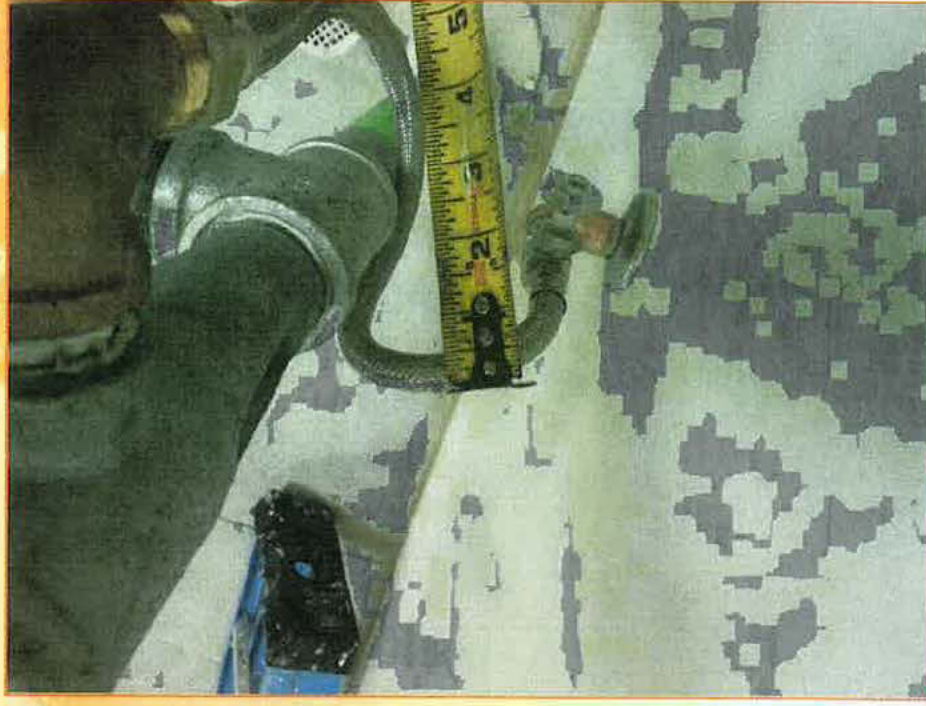
Manufacturer requires 1-1/4" supply line with 20gal/min. 1/2" line was installed with 6 gal/min flow.

- ☐ Shower must deliver minimum of 20 gallons (75.7L) per minute and provide a column of water 20 inches (50.8 cm) wide at 60 inches (152.4 cm) above the surface floor of user. (Sec. 4.1.2, 4.1.4, 7.1)

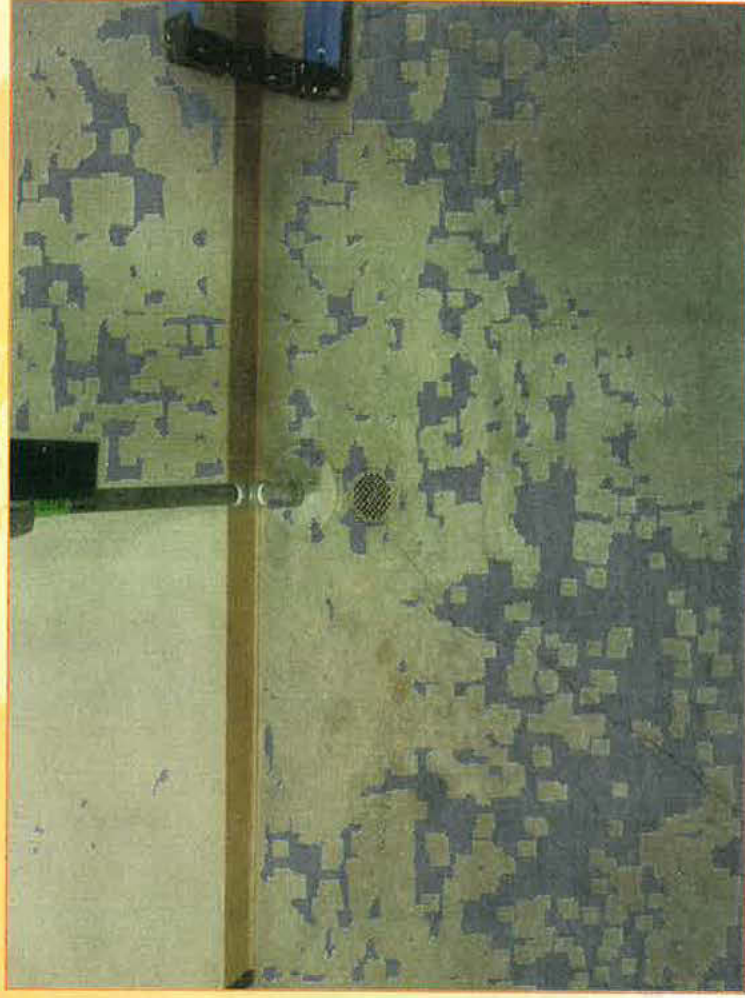
### 13.4 Emergency eye wash/shower -

Manufacturer requires proper drainage. The as-built condition will allow the flat drainage to flow into the office.

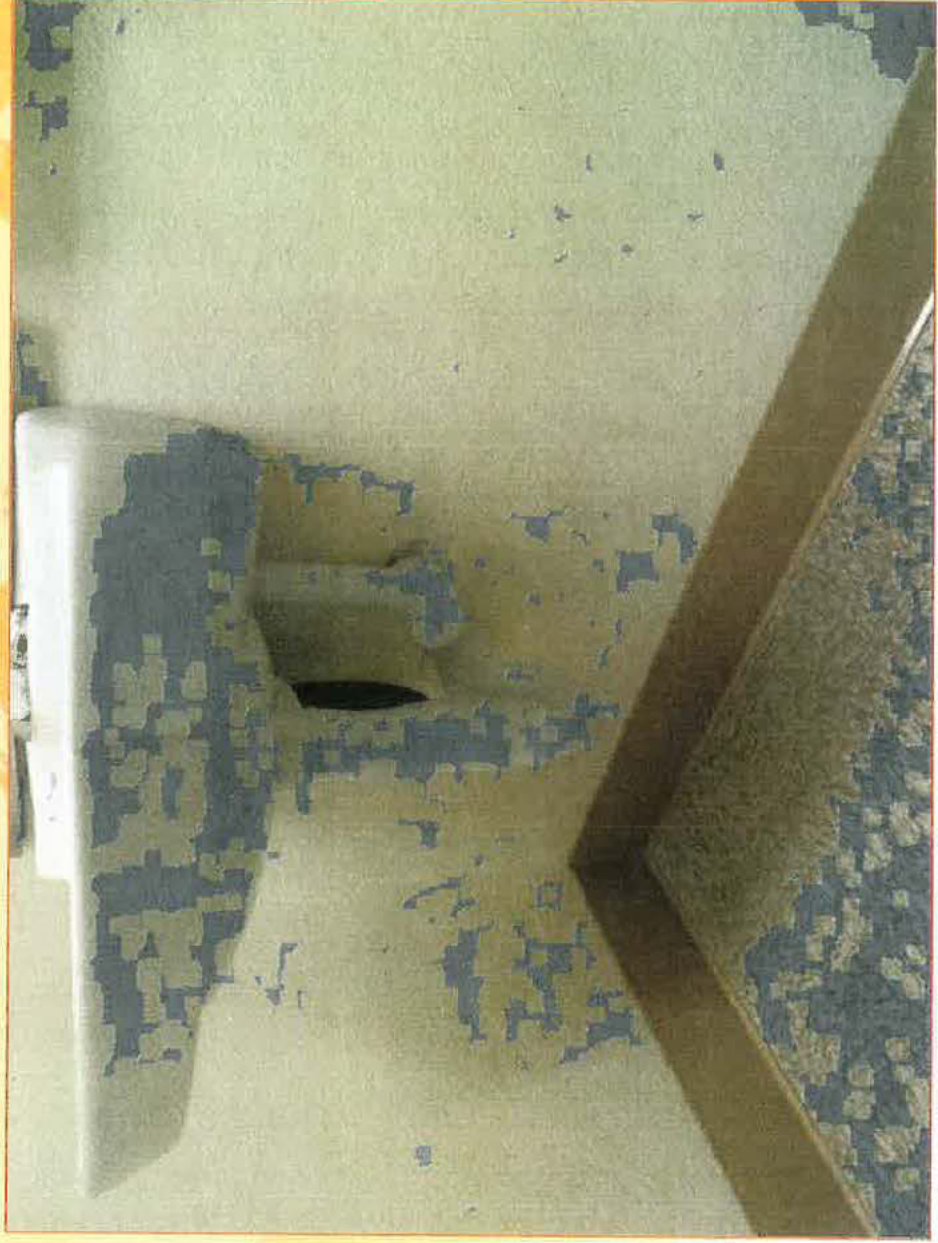
### 13.6 Plumbing Vent Pipe -

Vent piping for restroom fixtures is only 2" diameter. Plans call for 3" diameter.

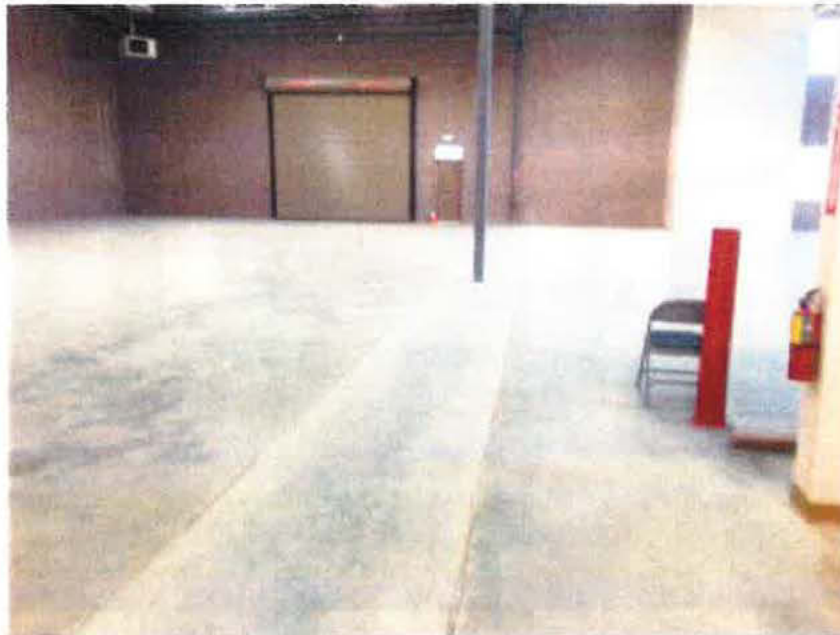
*Photograph of area of concrete floor that had been replaced*

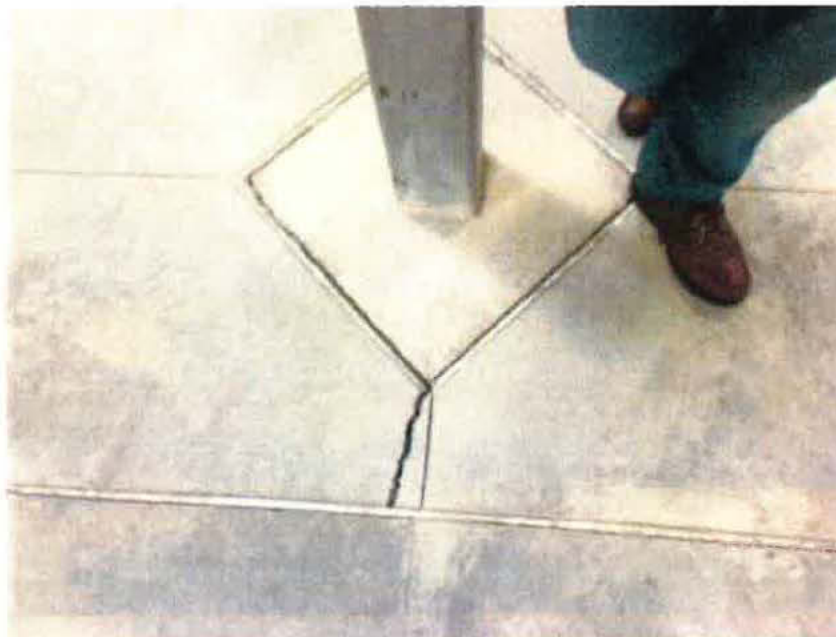
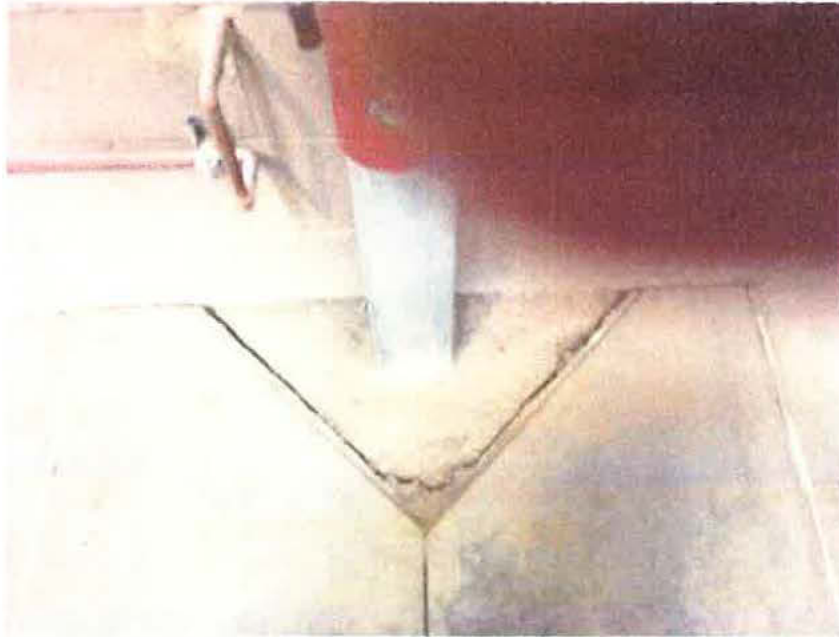
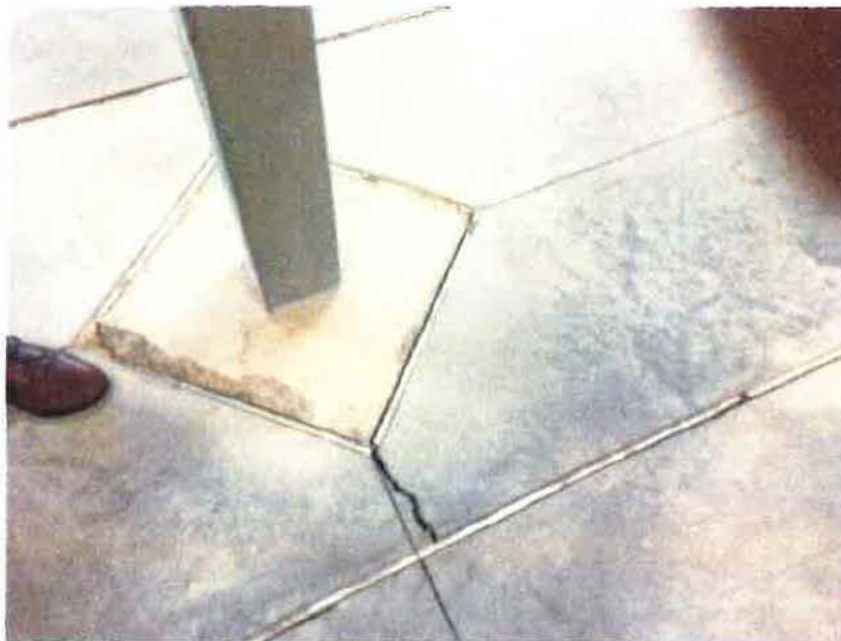
*Photograph of cracking around support posts after replacement of floor area*

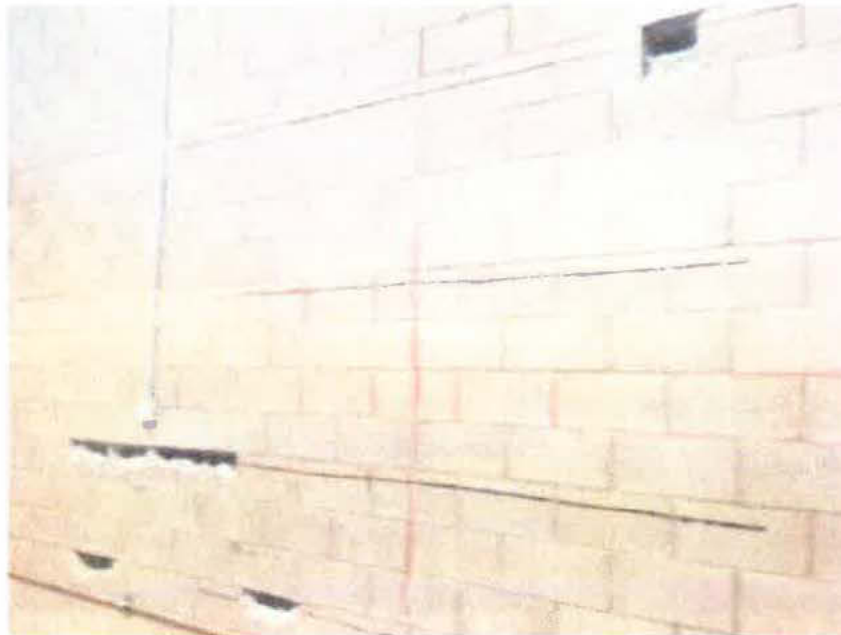
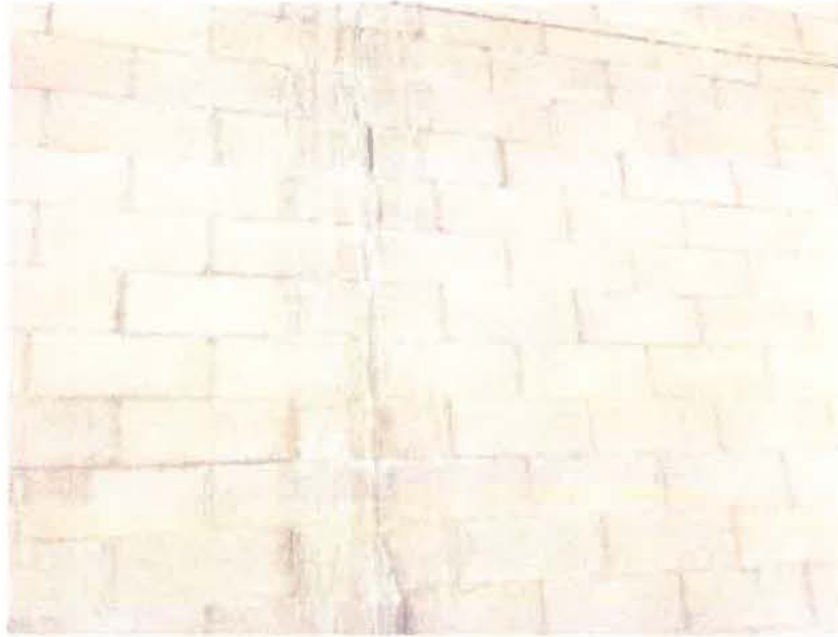
***Photograph of cracking area along concrete block wall***

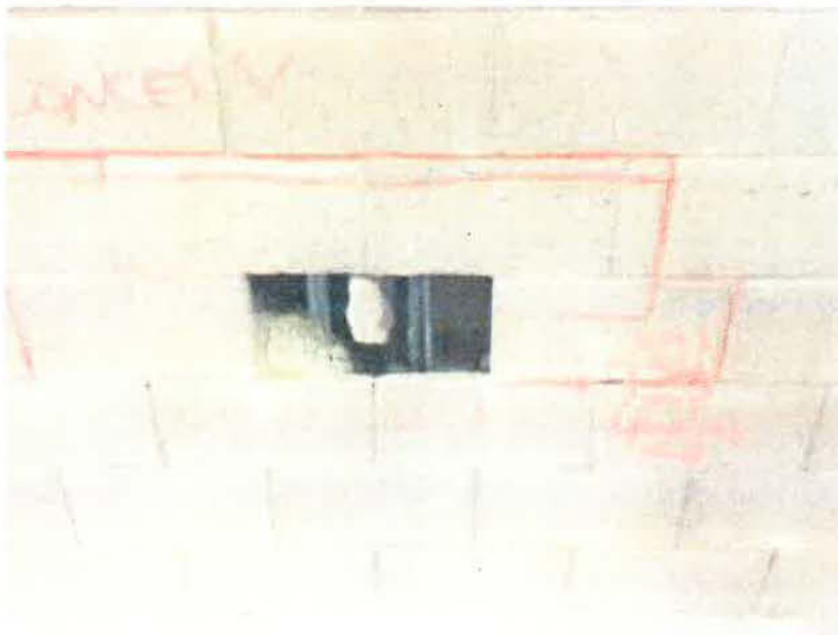
***(2256) Photograph of concrete block areas which did not have interior grouting***
